Bethel For All

Bethel Walk Audits

Survey Results: April – May 2022

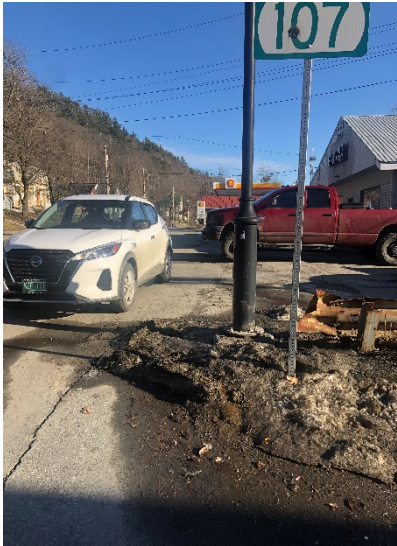
Left: sidewalk is discontinued before the auto repair store; haphazard parking, street light and snow piles obstruct the walking route.

2. Install a temporary walking path along Main Street where there is no sidewalk using paint and large planters to create a space marked specifically for pedestrians with consideration of installing a permanent sidewalk eventually.

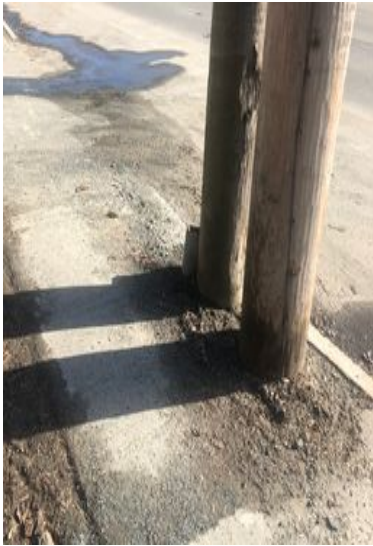
Middle: utility poles obstruct an already-narrow sidewalk on the south/east side of Main Street, making it hard for wheelchairs or strollers to pass.

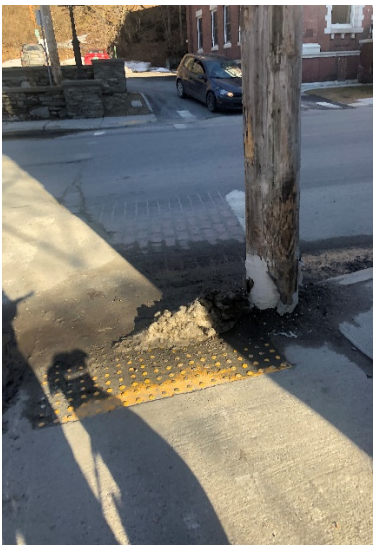
Right: truncated domes are frequently filled with debris, sand, or snow piles, creating hazards for people with disabilities.

3. Create a schedule, budget and plan for more regular cleanup, line painting, and removal of debris along sidewalk and crosswalks throughout the village.

- Educate road crews about accessibility and the importance of fully removing snow and debris from areas that can create hazards.
4. Create a regular inspection and repair schedule and checklist for sidewalk and crosswalk infrastructure.

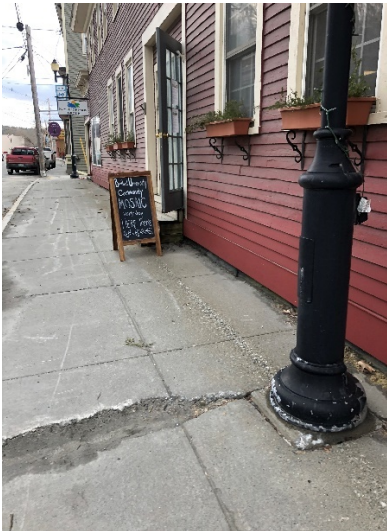
Left: minor cracks in the sidewalk need repair and could be opportunities for integrating art (such as mosaic) into infrastructure. Middle and right: breaks in the sidewalk route and errant snow piles make walking hard on the north/west side of Main Street between the Wall and Bethel Central Market.

5. Repair minor sidewalk cracks and holes and broken elements.
 - Consider using artistic and community-driven techniques, such as mosaic art.
6. Create more pocket parks and places to sit downtown.

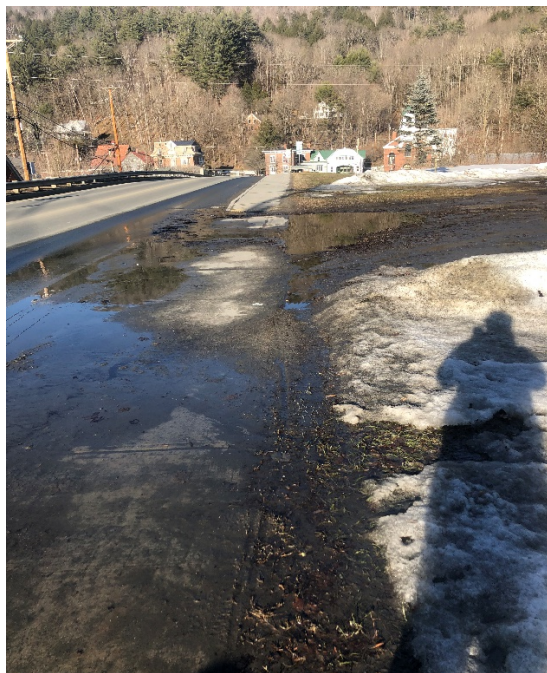
Left: Driveways create breaks in the sidewalk network and collect rainwater and snowmelt on Church Street, leading to hazardous ice and silt buildup.

6. Install pedestrian signage and pedestrian-scale lighting along Church Street and Pleasant Street.
7. Complete minor repairs to sidewalks and driveway entrances from the Town Hall to Sand Hill Road to manage stormwater and reduce ice/debris hazards.

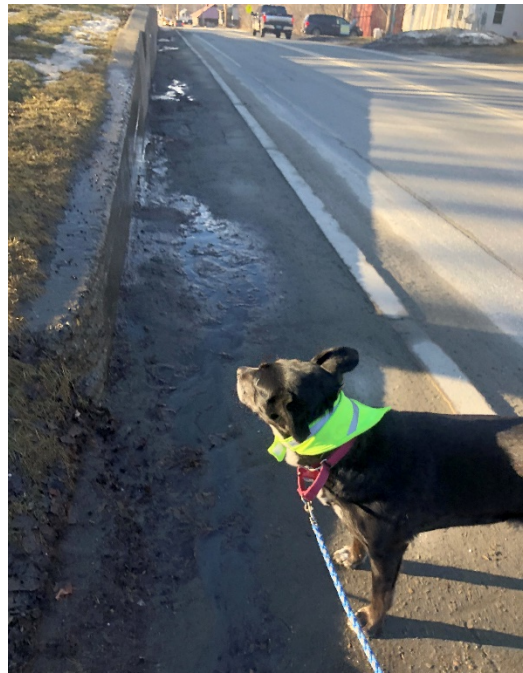
Right: A retaining wall on Pleasant Street is obstructing and narrowing the sidewalk and leading to buildup of stormwater and debris.

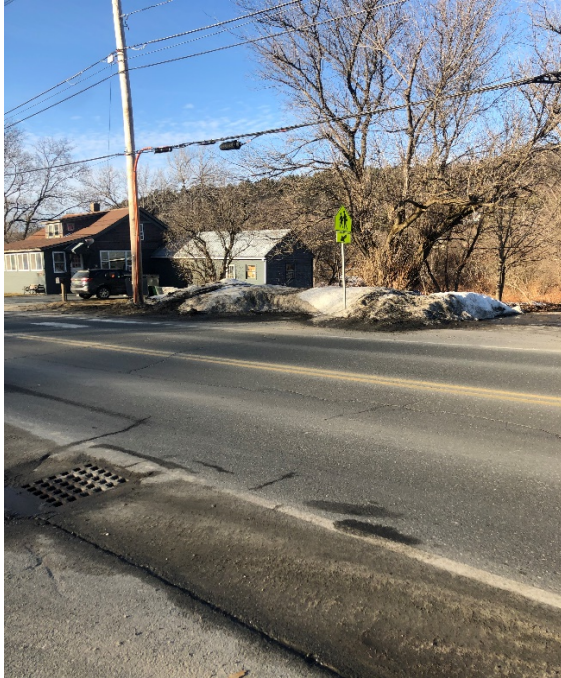
Left: Students only have one crosswalk connecting the school and athletic fields. It's typically blocked by a large snow pile in winter and has no sidewalk on the east side.

1. Install or reroute crosswalks at the Athletic Fields entrance, Sand Hill Road, and across the School / Nolato GW entrance.
2. Consider installing Rapid Flashing Beacons at the Brick Church crosswalk, and the Athletic Fields crossing to increase safety and visibility for pedestrians crossing the street.
3. Install pedestrian signage and pedestrian-scale lighting along Church Street and Pleasant Street.
4. Complete minor repairs to sidewalks and address drainage/stormwater management issues from the Town Hall to Sand Hill Road
5. Replace and widen the sidewalk from Sand Hill Rd. to the School in sections that are very narrow; repair the retaining wall.
6. Delineate a temporary sidewalk along the old Valley Motors lot (now vacant) with paint and/or large planters or barriers. Install a full sidewalk eventually. Consider the placement of a crosswalk in front of Valley Motors.

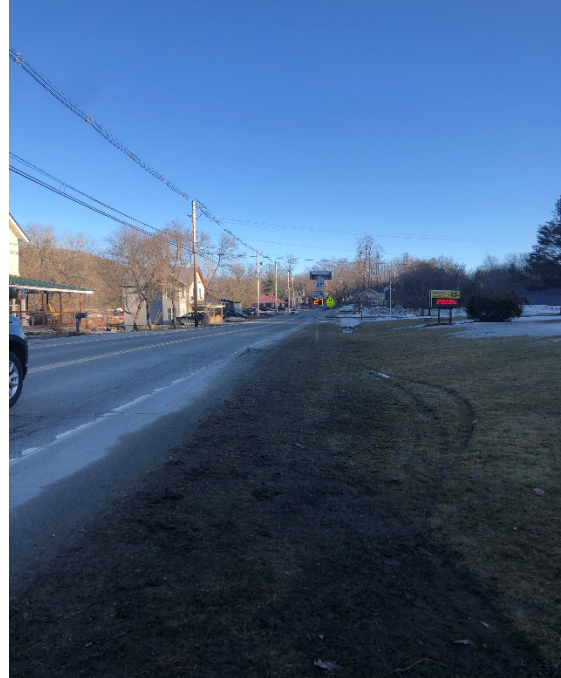
Right: The sidewalk ends south of the White River Valley School, so the school community and mobile home park residents have no safe walking route into town. High vehicle speeds and unsafe driving (evidenced by tire tracks on the lawn), stormwater ditch and snow banking leave the shoulder unsafe. An off-street walking path could be installed across the school lawn.

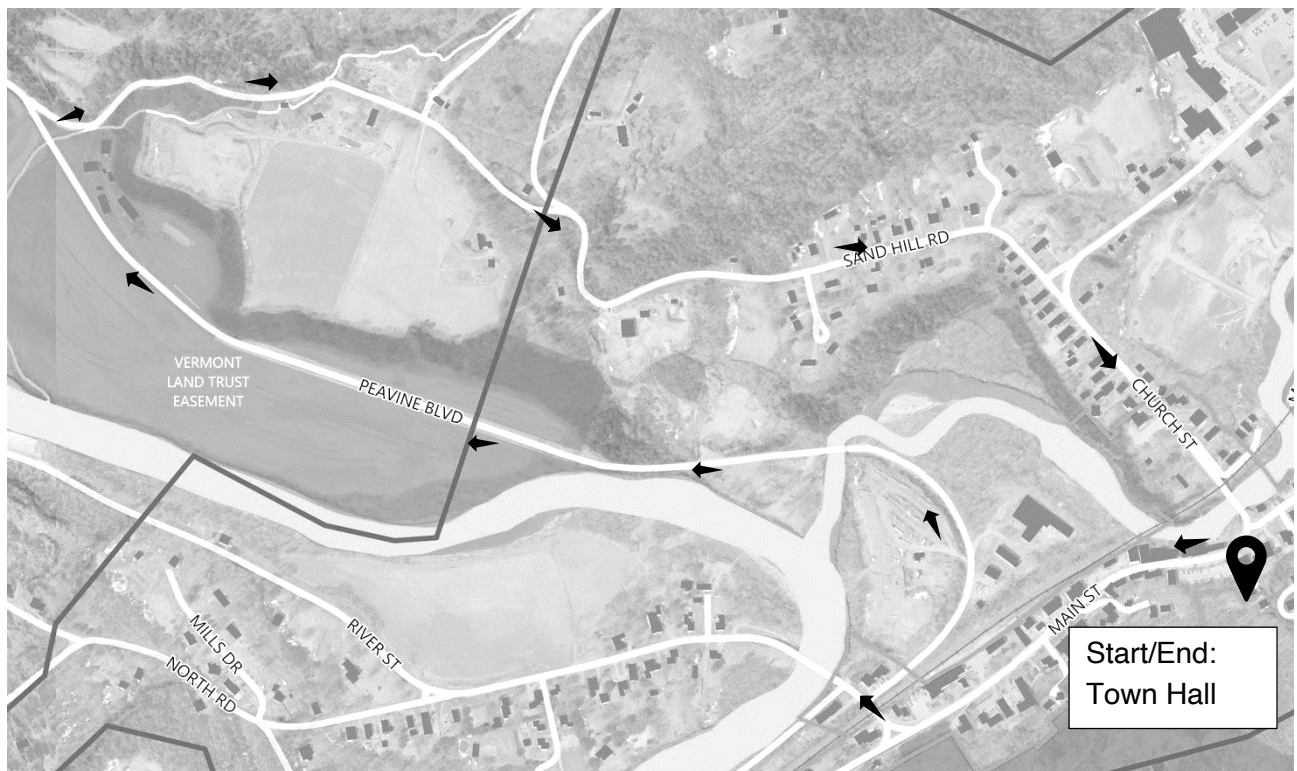
Audit #3: Peavine Boulevard Loop

Overall Findings: The participants found the walking conditions acceptable along most of the route. Participants identified lack of infrastructure, high speeds and driver behavior as problems on Peavine Boulevard itself and at the Rt. 12/107 intersection, and suggested investments in amenities to make the loop more inviting to bikers and pedestrians.

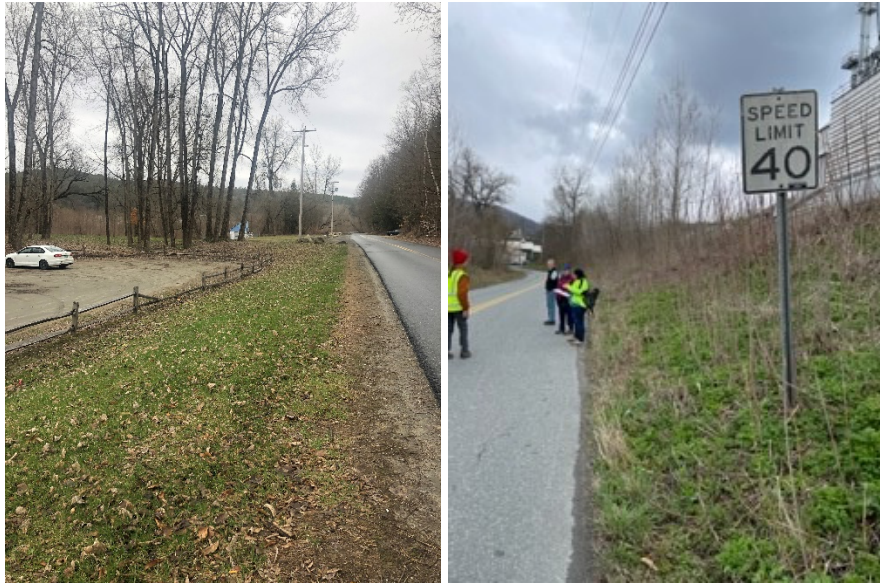
Top Left: Peavine Park is a great “launch point” for use of the Loop, but lacks accessible parking, bathroom access, and amenities.

Top Right: The road shoulder on Peavine Boulevard is adequate for walking in some sections, but is unsafe in places with blind corners, poison ivy and weeds, or snow bankings.

1. Create an ADA parking spot at Peavine Park, and widen the fence in order to allow for wheelchair users to pass through the fence and access the park.

8. Consider installing key park amenities at Peavine Park, such as a bathroom/latrine, maps, bike rack, and trash receptacle.

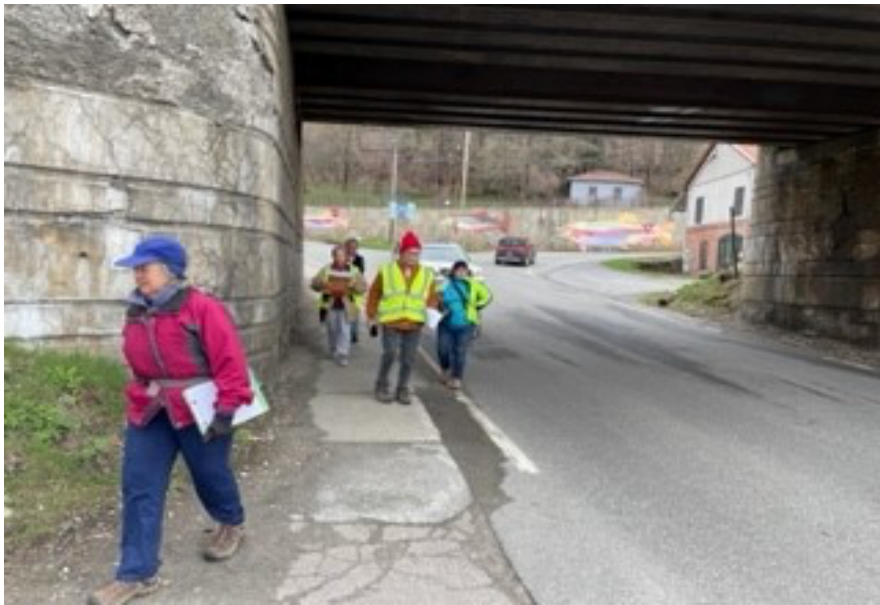
Bottom: The Rt. 107 underpass feels unsafe to walkers, with a narrow and broken sidewalk and no crosswalk.

2. Consider installing a crosswalk across Rt. 107 near the railroad underpass, and eventually redesigning the intersection to allow safe passage from downtown to South Main Street.

9. Work with VTrans to consider pedestrian safety at Rt. 107 near the railroad underpass, a crosswalk is needed to allow safe passage from downtown to South Main Street.
