Accessibility Audit and Overview for Bethel Village

Bethel for All: Village Accessibility Plan | Public Version

Prepared by Direct Access Consultancy LLC

October 2021

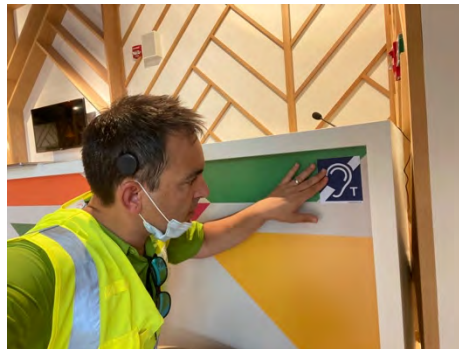
Within key areas of Bethel, there is a requirement for counter induction loops to benefit those with a hearing impairment. An induction loop helps people who use a hearing aid or loop listener to hear sounds more clearly because it reduces or cuts out background noise such as at a service counter. A hearing aid user would set their aid to the 'T' position and would only hear the staff member.

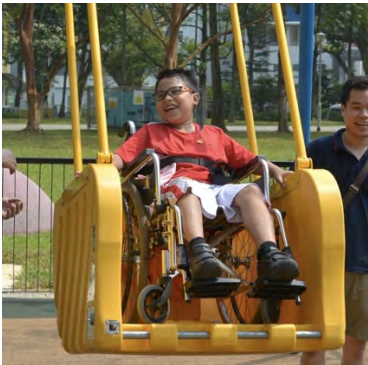
Fig 1: Wheelchair accessible swings.

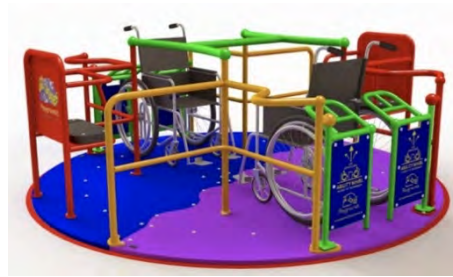
Fig 2: Wheelchair accessible roundabouts.

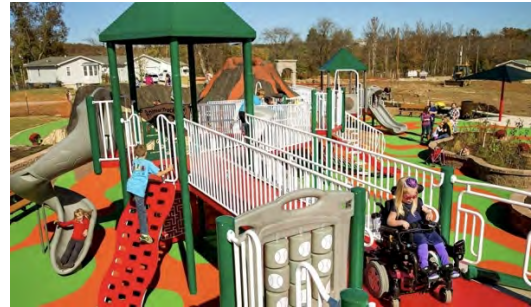
Fig 3: Climbing structures with accessible paths for wheelchair users.

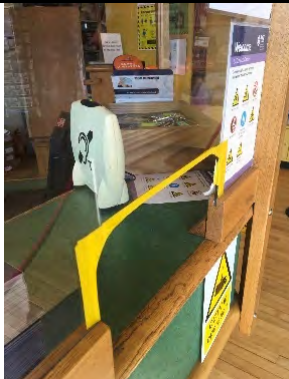
On arrival there was no hearing induction loop. This was found in storage and plugged back in and found to be working.	Implement a management procedure to keep the system in view of visitors and ensure that the correct signage is prominently displayed.

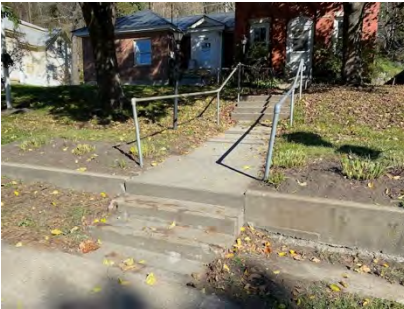
Item	Identification / Photo	Comment	Suggested Recommendation	Priority	Cost Band
1-Bethel Library

There is step free access available to the back of the library however there is no signage to indicate the availability of this.	Install signage illustrating the International Symbol of Access (wheelchair symbol) along with an arrow to show that step free access can be achieved to the back.	2	\$

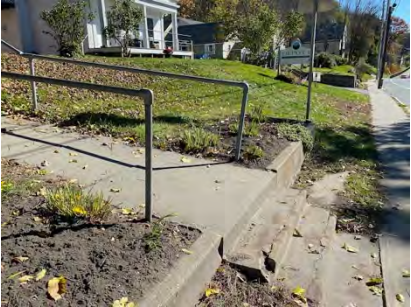
<p>The steps and pathways around the library are in poor condition and repair works should be undertaken to eliminate the potential hazards.</p>	<p>Repair works should be undertaken to the paving to eliminate the potential tripping hazard.</p> <p>Uneven surfaces, surfaces of loose materials (e.g. gravel) and large gaps between paving materials cause problems for wheelchair users, people with impaired vision and people who are, generally, unsteady on their feet.</p>	<p>2</p>	<p>\$</p>

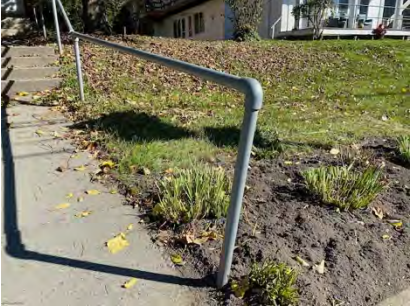
<p>4- Bethel Library</p>

<p>The handrails for the steps to the front of the library are of exposed metal which is likely to make them extremely cold to touch during colder months.</p>	<p>The handrails should be coated with nylon or a suitable alternative to ensure that they are not cold to touch. In locations subject to extremely cold temperatures such as Bethel, handrails should not become excessively cold to touch, while being of a material that, if necessary, is sufficiently robust to resist vandalism or misuse.</p>	<p>3</p>	<p>\$</p>

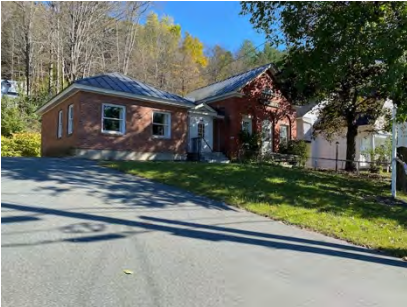
<p>5- Bethel Library</p>

<p>The library has a steep driveway leading to the back entrance which is where the step free access is also available for wheelchair users. Many people are likely to find the gradients difficult to negotiate also potentially during colder months when it is icy.</p>	<p>Consideration to installing a free-standing handrail to one side. This should be well contrasted and not cold to touch.</p> <p>Top of gripping surfaces of handrails should be 34 inches (865 mm) minimum and 38 inches (965 mm) maximum vertically above the ground. Handrails should be at a consistent height above the ground floor level.</p>	<p>2</p>	<p>\$</p>
<p>6- Bethel Library</p>

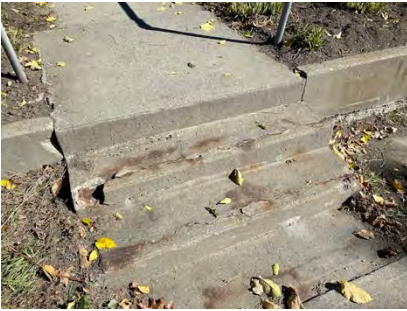
<p>None of the library steps have color contrast provided to the edge of the step nosings. This could make them difficult to see and cause a potential tripping hazard.</p>	<p>It is recommended that color contrast be painted to the edge of the step nosings to clearly highlight their presence.</p> <p>This will help people who are blind or partially sighted to appreciate the extent of the stairs and identify individual treads.</p>	<p>2</p>	<p>\$</p>

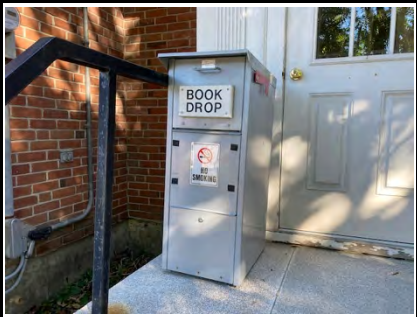
<p>8- Bethel Library</p>

<p>The book drop off is positioned to the top of the main entrance steps. This means that wheelchair users or those who require step free access would be unable to access it.</p>	<p>Consider relocating the unit to an area in which those who require step free access would be able to access it.</p>	<p>2</p>	<p>N</p>
<p>9- Bethel Library</p>

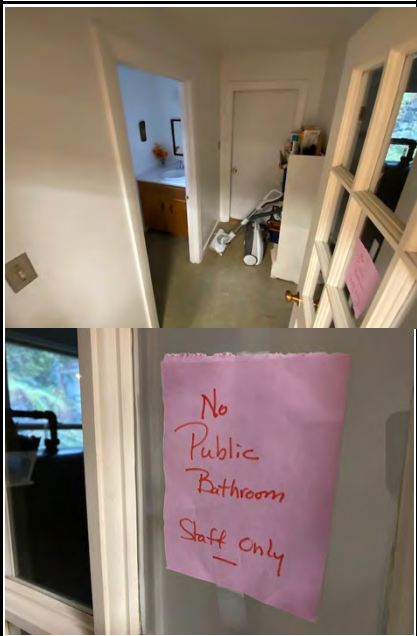
<p>At current the restroom facilities are not available for the public. There is a great opportunity to provide a large ADA compliant accessible bathroom for people with disabilities in the future.</p>	<p>To be considered. This would give many people with disabilities the confidence to go and visit the library. The ADA provision requirements state that where any type of sanitary facility is available to the public some must be to ADA accessible specifications, as detailed in ADA 603, 604 213 and 214.</p>	<p>2</p>	<p>\$\$</p>

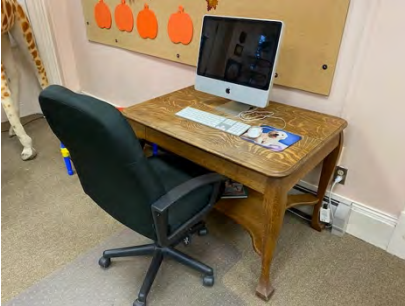
<p>10- Bethel Library</p>

<p>Within the library, all of the work benches are set at fixed heights. Not all wheelchair users would find these easy to use.</p>	<p>Consideration should be given to providing one height adjustable table within the library for people with disabilities.</p>	<p>3</p>	<p>\$</p>
<p>11- Bethel Library</p>

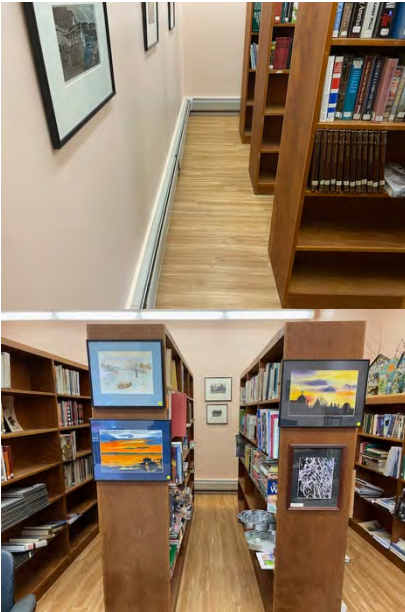
<p>Due to the size of the library, it is not possible to have wide aisles to accommodate those who require greater maneuverability such as wheelchair users.</p>	<p>This is deemed feasible to retain as less shelves would result in substantially less content. It is recommended that signage be installed stating that assistance can be provided on request. This sign should illustrate the International Symbol of Access (wheelchair symbol)</p>		<p>3</p>

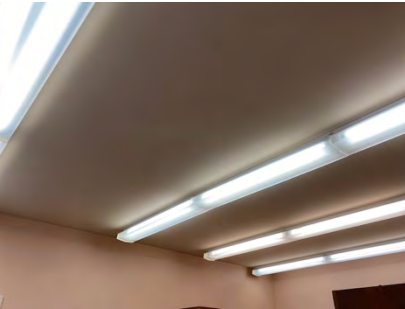
<p>12- Bethel Library</p>

<p>The lighting within the library could be improved.</p>	<p>A lighting review should be undertaken. A new consistent lighting scheme should be designed which does not have reflections, glare and deep shadows.</p> <p>Lighting should create a confusion-free environment that avoids excessive reflection, glare, deep shadows and wide variations in lighting levels. The lighting design should aim to achieve this by controlling the location, quantity and quality of both natural and artificial light.</p>	<p>3</p>	<p>\$</p>
<p>13-B Bethel Library</p>

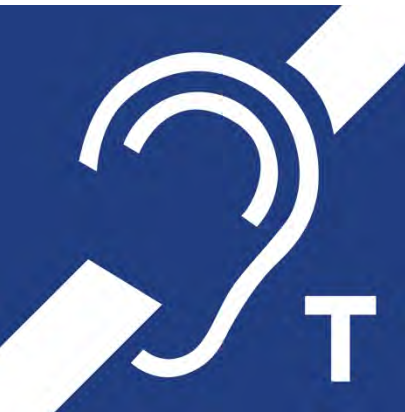
<p>There is no induction loop provided at the library desk to accommodate those who have a hearing impairment.</p>	<p>It is recommended that an induction loop be installed to the reception desk. Signage indicating the availability of the facility should be provided and staff members should be aware in how to use the system.</p> <p>Direct Access always recommends an induction loop be installed at service or reception counters. ADA also states, in each assembly area where audible communication is integral to the use of the space, an assistive listening system should be provided.</p>	<p>2</p>	<p>\$</p>

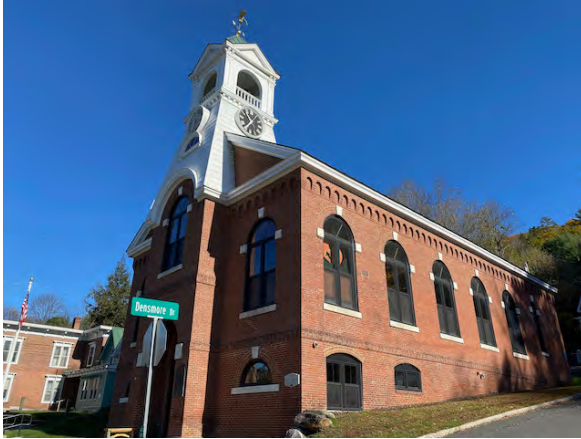
Item	Identification / Photo	Comment	Suggested Recommendation	Priority	Cost Band
1-Town Hall		<p>The steps up to main entrance from the side walk do not have any color contrast provided to the edge of the step nosings. This could cause a potential tripping hazard.</p>	<p>It is recommended that color contrast be painted to the edge of the step nosings to clearly highlight their presence. This will help people who are blind or partially sighted to appreciate the extent of the stairs and identify individual treads.</p>	2	\$

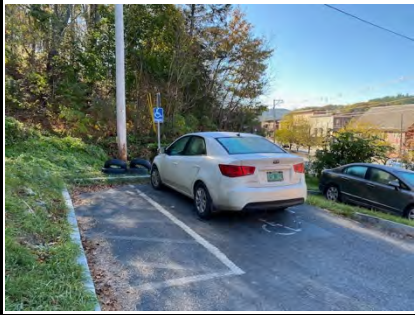
2-Town Hall

The ADA accessible parking space provided to the top opposite the accessible entrance should be remarked.	Remark the existing accessible parking space at least 8 feet wide with an access aisle atleast 5 feet wide. This should follow the set guidelines as per ADA [502.2, 502.3]	2	\$
3- Town Hall

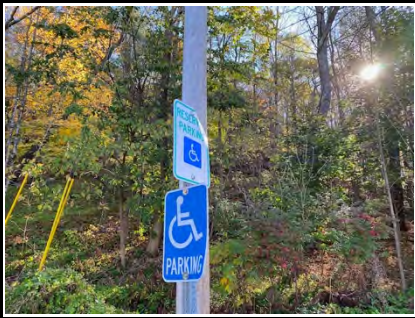
The ADA accessible parking space provided to the top opposite the accessible entrance shas a sign which requires fixing.	Implement repairs to the signage.	3	\$
4- Town Hall

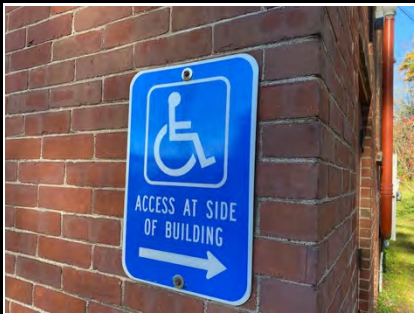
On approach to the main entrance, it may not be immediately evident that step free access into the hall is provided via the side of the building. It is recommended that further signage be provided.	Provide further signage. Refer to ADA [216.6]	2	\$

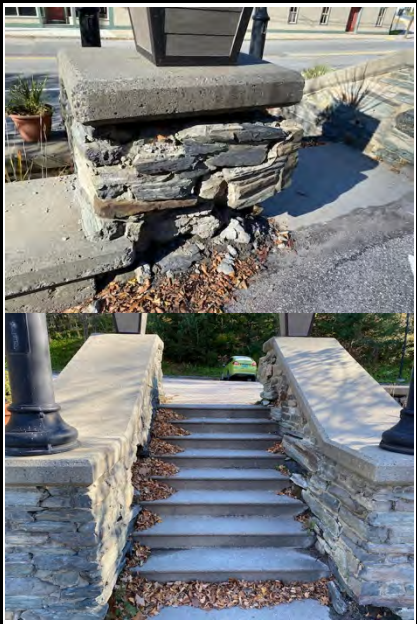
<p>5- Town Hall</p>

<p>The 8 steps from the side walk to the town hall car park has a crumbling top pillar which could cause a potential hazard. The steps also have no color contrast provided to the edge of the step nosings or handrails provided.</p>	<p>Repair works should be undertaken to the top pillar to remove the potential hazard. Color contrast should be provided to the edge of the step nosings and ADA compliant handrails should be installed to both sides.</p>	<p>1</p>	<p>\$</p>
<p>6- Town Hall</p>

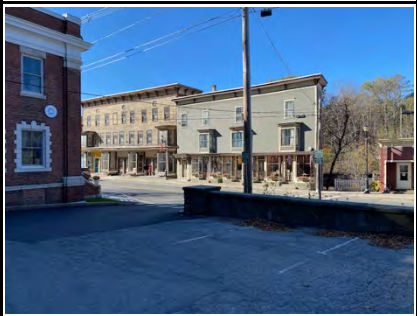
<p>Within the Town Hall car park it would be extremely beneficial to provide a further two ADA compliant accessible parking spaces. Ideally two bays closest to the bank if they would be willing to swop them around.</p>	<p>The accessible parking spaces should be at least 8 feet wide with an access aisle at least 5 feet wide. This should follow the set guidelines as per ADA [502.2, 502.3]</p>	<p>2</p>	<p>\$</p>

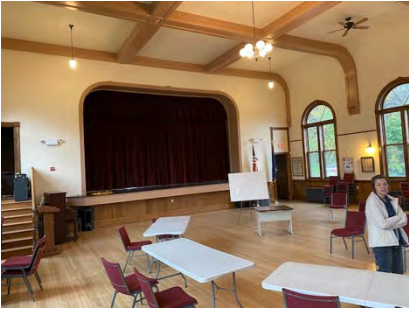
7- Town Hall

<p>Within the main hall, many functions take place and there is a stage however there is no hearing enhancement system available for those who have a hearing impairment.</p>	<p>Consideration should be given to installing an induction loop to benefit hearing aid users.</p> <p>A hearing enhancement system, using induction loop, infrared or radio transmission, should be installed in rooms and spaces used for meetings, lectures, classes, performances, spectator sport or films, and at service or reception counters where the background noise level is high.</p>	2	\$
8- Town Hall

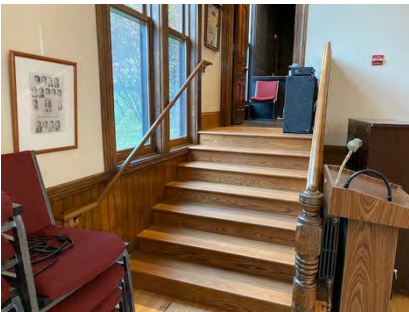
<p>The steps to the left side of the stage should have color contrast provided to the edge of the step nosings to prevent a potential tripping hazard.</p>	<p>Nosing strips should be installed to the edge of the steps.</p> <p>It is very helpful for steps to have clear color contrast edgings applied to nosings permanently contrasting material 55mm wide on both the tread and the riser.</p>	2	\$

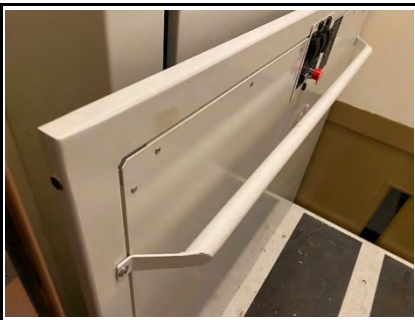
10- Town Hall

The support rail for the platform lift is not color contrasted against the background upon which it is seen.	Color contrast should be provided to the support rail to ensure that it can be easily distinguished by people with impaired vision.	3	\$
11- Town Hall

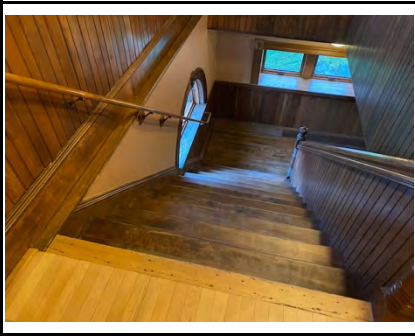
The main steps should have color contrast provided to the edge of the step nosings to prevent a potential tripping hazard.	Nosing strips should be installed to the edge of the steps. It is very helpful for steps to have clear color contrast edgings applied to nosings permanently contrasting material 55mm wide on both the tread and the riser.	2	\$
12- Town Hall

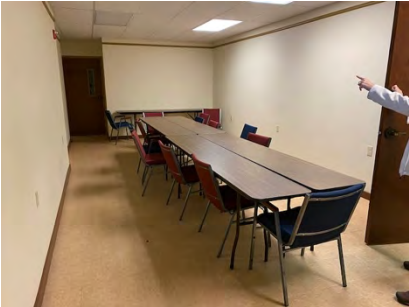
<p>13- Town Hall</p>

<p>There is a conference room however there is no hearing enhancement system available for those who have a hearing impairment.</p>	<p>Consideration should be given to installing an induction loop to benefit hearing aid users.</p> <p>A hearing enhancement system, using induction loop, infrared or radio transmission, should be installed in rooms and spaces used for meetings, lectures, classes, performances, spectator sport or films, and at service or reception counters where the background noise level is high.</p>	<p>2</p>	<p>\$</p>
<p>14- Town Hall</p>

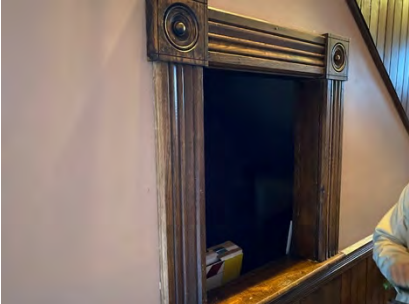
<p>On the ground floor there is a hatch which is sometimes used to sell or disperse tickets. It is not clear if this is still currently in use, if so then this should feature an induction loop.</p>	<p>An induction loop should be installed to the counter.</p>	<p>3</p>	<p>\$</p>

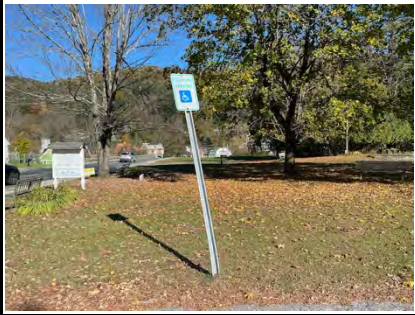
2- Bandshell Park

One of the signs for the ADA parking spaces is not standing upright.	Repair works should be undertaken to the post to ensure that it is standing upright.	3	\$	
3- Bandshell Park

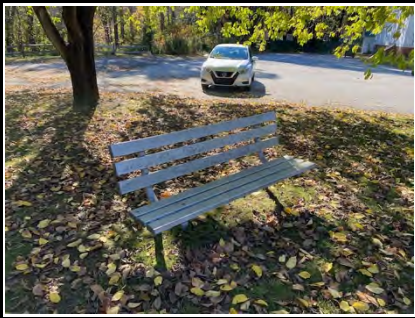
The metal bench seating provided is likely to be extremely cold during certain months of the year. Additionally there are no armrests provided to aid ambulant disabled persons.	It is recommended that new seating be invested in. Ensure that the armrests are well contrasted and that there is a space either side of the seat so that a wheelchair user can park alongside a seated companion		3	\$
4- Bandshell Park

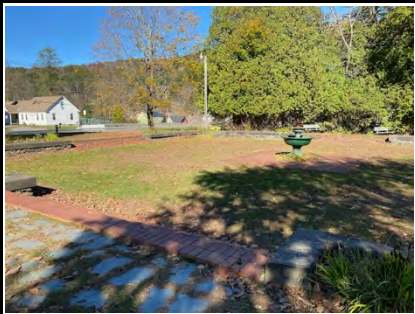
At current the central fountain and plaza are not accessible for wheelchair users or for those unable to negotiate steps.	It is recommended that consideration be given to making one side a ramp to provide access to the plaza and fountain.			3

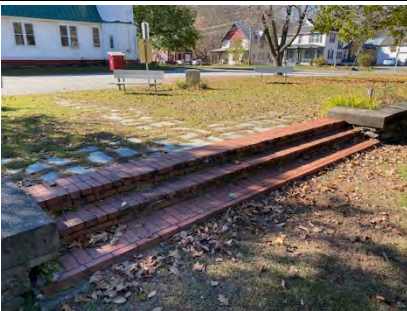
5- Bandshell Park

None of the steps feature color contrast to the edge of the step nosings and there are no handrails provided.	It is strongly recommended that color contrast be provided to the edge of the steps and free standing handrails be installed.	2	\$
6- Bandshell Park

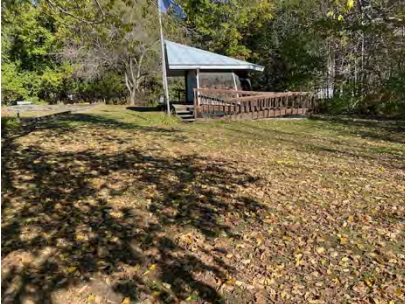
8- Bandshell Park

<p>There is no hard standing pathway leading up to the stage ramp. This means wheelchair users (or those unsteady on their feet) would find it difficult to access the stage especially should the ground be wet.</p>	<p>Create a hard standing pathway leading up to the ramp. This will ensure that wheelchair users and those unsteady on their feet would be able to access the stage.</p>	2	\$\$
9-Bandshell Park

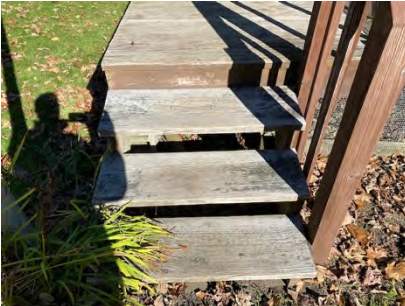
<p>The steps up to the stage have open risers which can cause a potential tripping hazard. There are also no color contrast provided to the edge of the steps.</p> <p>When steps are open, this can also make service dogs apprehensive to proceed due to being able to see through the gaps.</p>	<p>It is recommended that the edge of the steps be filled in to eliminate the potential tripping hazard.</p> <p>Color contrast should be applied to the edge of the steps.</p>	2	\$

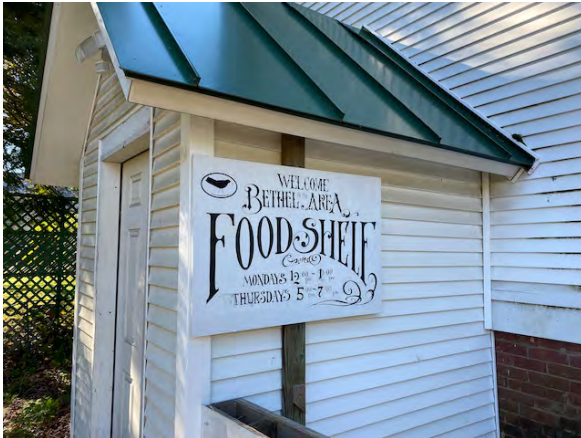
Item	Identification / Photo	Comment	Suggested Recommendation	Priority	Cost Band
1-Food Shelf	Parking	One ADA parking space should be considered for outside the Food Shelf main entrance.	Provide one accessible parking space at least 8 feet wide with an access aisle atleast 5 feet wide. This should follow the set guidelines as per ADA [502.2, 502.3]	2	\$

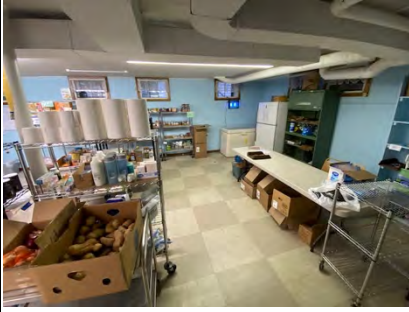
2- Food Shelf

<p>There is no step free access available down to the food shelf. This provides a vital service to the local community.</p>	<p>This is not deemed viable to provide and there is very limited/or no scope to provide this on the ground floor. It is recommended consideration be given to relocating this to Main Street if feasible.</p> <p>In the short term, an easy to reach assistance bell should be provided near the main entrance which can be accessed.</p>	1	\$
3- Food Shelf

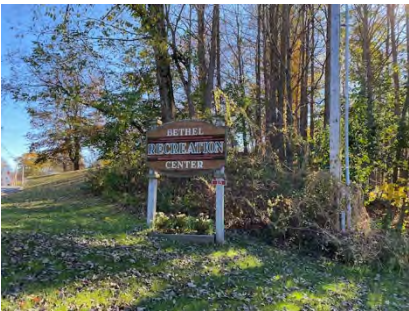
<p>The site identification could be improved. Many motorists are likely to drive past.</p> <p>Generally words entirely in upper case type (capital) should be avoided. A sans serif type face with a relatively large “capital” height to “x” height should be used.</p>	<p>Recommended that new site identification signage be considered. Signage should be in upper and lower case if possible.</p>	3	\$

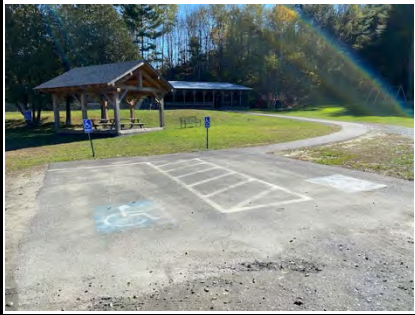
The ADA parking spaces have now faded and are barely distinguishable.	Bays should be repainted as per ADA requirements. The accessible spaces should be at least 8 feet wide with an access aisle at least 5 feet wide	2	\$
3- Recreation Centre

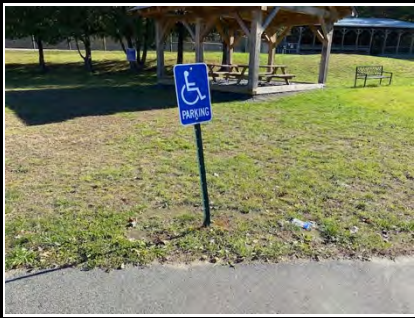
The signage to one of the ADA parking spaces is slanted and requires repositioning.	Reposition signage to ensure that the accessible parking space can be easily identified.	2	\$
4- Recreation Centre

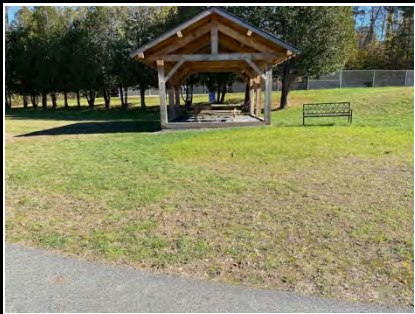
There is no hard standing pathway leading up to the covered picnic area. Many wheelchair users are likely to find it difficult to access this area especially if the ground is wet.	Consider creating a pathway. Pathway should be at least 36" as per ADA requirements. Wider would be even further beneficial.	2	\$\$

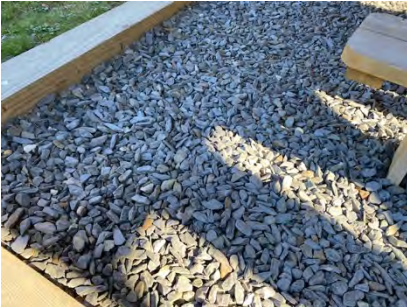
7- Recreation Centre

The picnic area has a graveled surface which can trap the wheels of a wheelchair.	<p>It is recommended that consideration be given to changing the surface to one that is hard standing.</p> <p>Uneven surfaces, surfaces of loose materials (e.g. gravel) and large gaps between paving materials cause problems for wheelchair users, people with impaired vision and people who are, generally, unsteady on their feet.</p>	3	\$
8- Recreation Centre

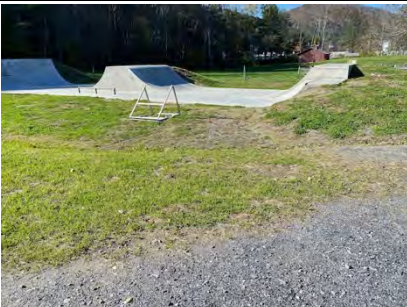
There is no pathway leading up to the skate park to aid wheelchair users.	Consider creating a pathway. Pathway should be at least 36" as per ADA requirements. Wider would be even further beneficial.	2	\$\$
9- Recreation Centre

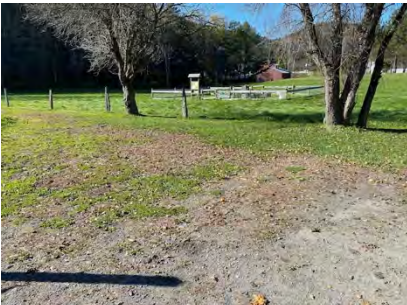
There is no pathway leading up to the Bethel Community Teaching Garden to aid wheelchair users.	Consider creating a pathway. Pathway should be at least 36" as per ADA requirements. Wider would be even further beneficial.	2	\$\$

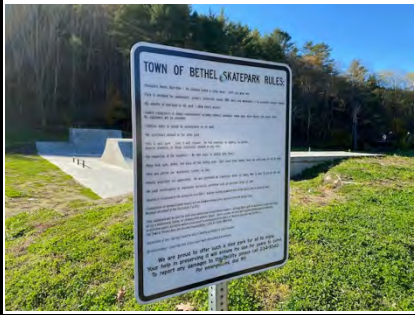
10- Recreation Centre

The signage for the skatepark rules has a very small type font that many may struggle to read. The notice is also not pictorial.	Consider replacing using pictorial information and larger type fonts.	3	\$
11- Recreation Centre

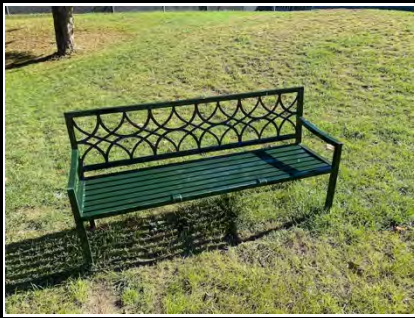
The benches are green seen against grass. This does not provide sufficient color contrast, additionally there is no space to the side for wheelchair users.	Consider painting the benches a color which will contrast against the surround upon which they are seen. Also provide a hard standing space to the side for wheelchair users.		3
12- Recreation Centre

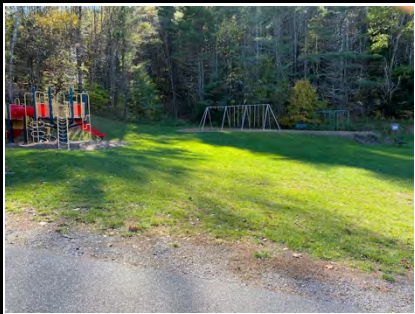
There is no pathway leading up to the play equipment to aid wheelchair users.	Consider creating a pathway. Pathway should be at least 36" as per ADA requirements. Wider would be even further beneficial.	2	\$\$

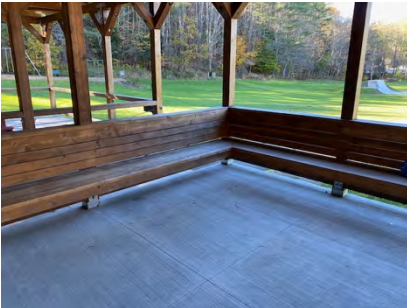
13- Recreation Centre

None of the benches within the covered area adjacent to the pool feature armrests to aid ambulant disabled persons.	Consider providing a drop down rail to one side of the seating to aid ambulant disabled persons.	3	\$
14- Recreation Centre

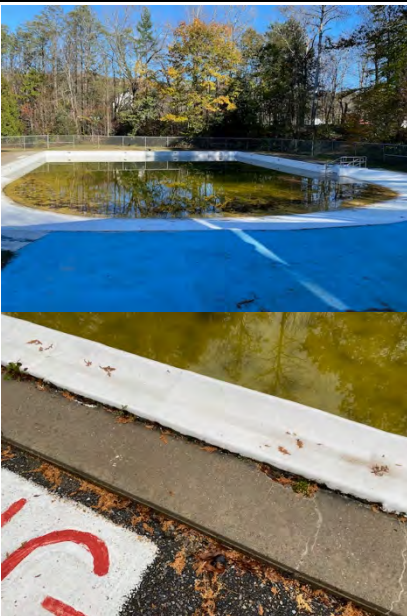
The edges of the swimming pool are not well defined. It is likely that the edging could cause a potential foot injury.	Consider redefining the edges of the swimming pool as part of a long term renovation programme.		\$\$

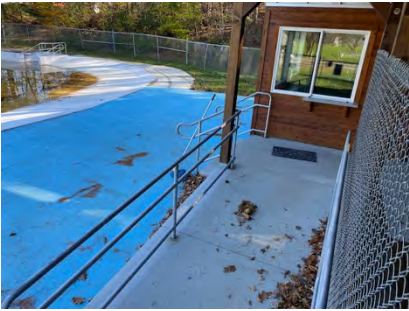
<p>15- Recreation Centre</p>

<p>Whilst not an ADA requirement, it would be beneficial to add color contrast to the surface of the ramp to indicate the presence of a gradient. Additionally, the handrails should be painted a contrasting color.</p>	<p>Color contrast should be added to the surface of the ramp. The surface of a ramp should contrast visually with the landings and the edge protection so that its presence is discernible by people who are blind or partially sighted.</p> <p>The handrails should be painted a contrasting color to aid people who have impaired vision.</p>	<p style="text-align: center;">3</p>	<p style="text-align: center;">\$</p>
<p>16- Recreation Centre</p>

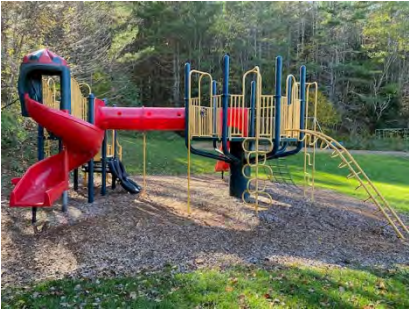
<p>There is no play equipment provided for people with disabilities.</p>	<p>There is a great opportunity to consider the provision of accessible play equipment within Bethel Recreation Park.</p> <p>Play areas should be designed to be inclusive and accessible for people with a variety of impairments. Bethel could consider installing play equipment which can be used by people with disabilities who require the use of wheelchairs or have mobility impairments. Refer to section 5.</p>		<p style="text-align: center;">3</p>

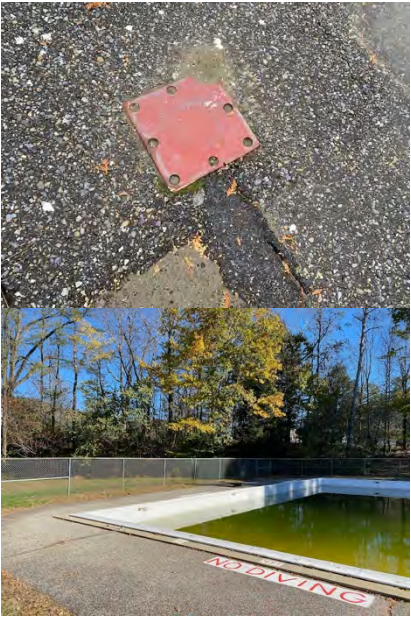
<p>It is understood that there used to be a swimming pool hoist system however this could not be traced.</p>	<p>It is recommended that Bethel invests in a new hoist system for the swimming pool. It would be beneficial to consider a mobile swimming pool lift which can be easier to use and feature more flexibility.</p>

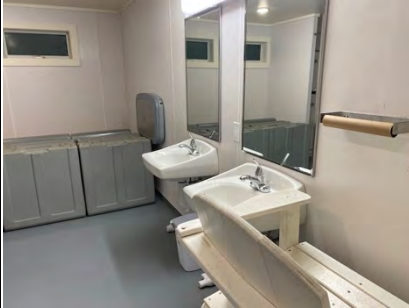
<p>19- Recreation Centre</p>

<p>The bathrooms are extremely well equipped however the color contrast is poor. Everything is white seen on a white background.</p>	<p>Greater contrast should be considered for the fixtures and fittings. This can be achieved by having light sanitary ware seen against a dark background or vice versa.</p> <p>To help blind and partially sighted people identify key objects within sanitary accommodation, support rails and grab rails should contrast visually with the wall, the WC seat and cover should contrast visually with the WC pan and cistern, and sanitary fittings and accessories should contrast visually with the background against which they are seen.</p>	<p>3</p>	<p>\$</p>
<p>20- Recreation Centre</p>

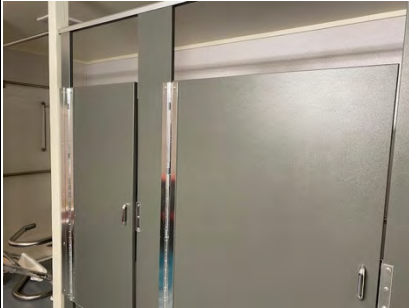
<p>The cubicle doors are not color contrasted against the side panels to aid people with impaired vision.</p>	<p>Add color contrast to the cubicle doors.</p>		<p>3</p>

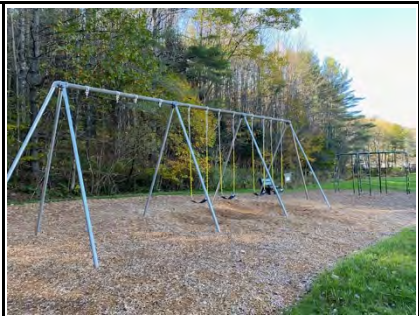
A harness would be extremely beneficial for the swing frame. This would make the feature more inclusive.	Consideration to procuring a harness. This will also need to be ideally in conjunction with recommendation 12-RC which is to create a hard standing pathway.	2	\$
-----------------------	---	--	--	----------	-----------

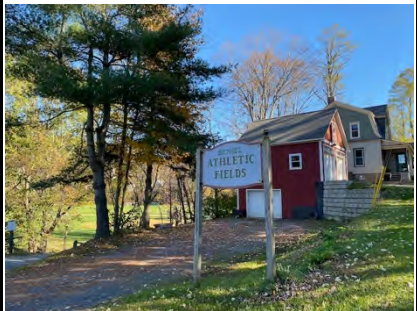
<p>The site identification could be improved. Many motorists are likely to drive past.</p> <p>Generally words entirely in upper case type (capital) should be avoided. A sans serif type face with a relatively large “capital” height to “x” height should be used.</p>	<p>Recommended that new site identification signage be considered. Signage should be in upper and lower case if possible.</p>	3	\$

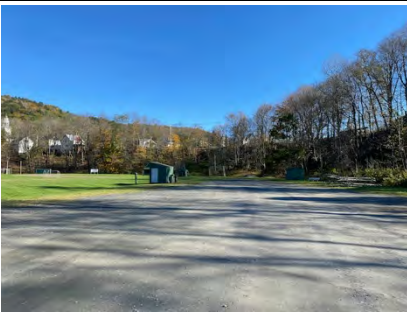
<p>2- Athletic Fields</p>

<p>Two ADA parking spaces should be considered for part of the large car park.</p>	<p>Provide two accessible parking spaces at least 8 feet wide with an access aisle atleast 5 feet wide. This should follow the set guidelines as per ADA [502.2, 502.3]</p>	<p>2</p>	<p>\$</p>
<p>3- Athletic Fields</p>

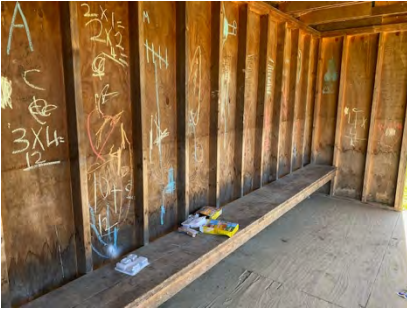
<p>None of the covered bench seating within the viewing huts feature armrests to accommodate ambulant disabled persons.</p>	<p>Consider installing a drop-down rail to one side of the bench seats.</p> <p>The 2010 ADA Standards contain elements that are not in the 1991 Standards. These elements include recreation facilities such as swimming pools, team and player seating, accessible routes to court sports facilities, saunas and steam rooms, fishing piers, play areas, exercise machines, golf facilities, miniature golf facilities, amusement rides, shooting facilities with firing positions, and recreational boating facilities. Because these elements are not in the 1991 Standards, they are not subject to the safe harbor exemption. State and local governments must make these items accessible if necessary to ensure program accessibility, unless an undue burden would result. Public accommodations</p>	<p>3</p>	<p>\$</p>

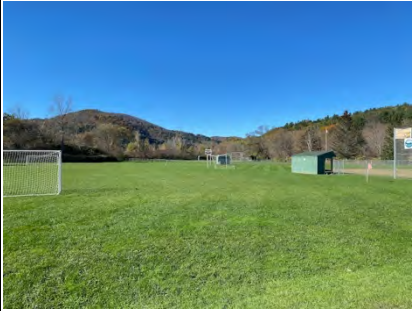
must remove architectural barriers to these items.		
4- Athletic Fields

There are no hard standing pathways or platforms to allow wheelchair users to spectate games/events.	Consider creating a pathway up to the pitches along with a platform area. Pathway should be at least 36" as per ADA requirements. Wider would be even further beneficial.	3	\$\$

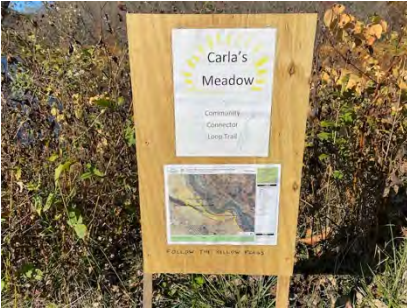
Item	Identification / Photo	Comment	Suggested Recommendation	Priority	Cost Band
1-Carla's Meadow

<p>Carla's Meadow is an area which is proposed to be an ADA trail. This is to run along the river.</p> <p>As part of the trail, we would recommend QR codes being installed along the route which will trigger audio narration for those who are vision impaired or sign language for those who are deaf or hard of hearing.</p>	<p>On September 26, 2013 the U.S. Access Board issued new accessibility guidelines for outdoor areas on federal lands. The guidelines provide detailed specifications for accessible trails, picnic, and camping areas, viewing areas, beach access routes, and other components of outdoor developed areas when newly built or altered.</p> <p>Requirements for trails and pedestrian access routes address surface characteristics, width, grade, and cross slope. Exceptions</p>	3	\$\$

<p>are included for these and other provisions under certain conditions stipulated in the guidelines.</p> <p>It is recommended that an Access Consultant is engaged for the design and creation of the ADA trail.</p>		
--	---	--	---	--	--

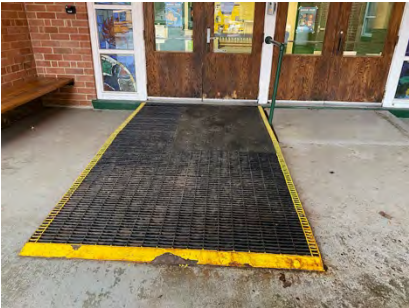
<p>5- School</p>

<p>At the moment the ramp for the school to provide step free access is temporary and it is recommended that a permanent ramp be built.</p>	<p>The ramp should be built to satisfy ADA criteria.</p> <p>The ramp should be at least 36 inches wide (405.5)</p> <p>The ramp surface should be durable, easy to maintain, slip-resistant when wet (to allow for rain and other environmental factors) The surface should also be well contrasted to minimise a potential stumbling hazard which can occur if a gradient takes someone by surprise.</p> <p>Landings should be provided at the foot and head of the ramp, they should be at least the width of the ramp and not less than 60 inches long.</p> <p>ADA compliant handrails should be provided to both sides which are of an oval profile, be well contrasted and not cold to touch as per ADA 505.7.1</p>	<p>2</p>	<p>\$\$</p>
------------------	---	---	---	-----------------	--------------------

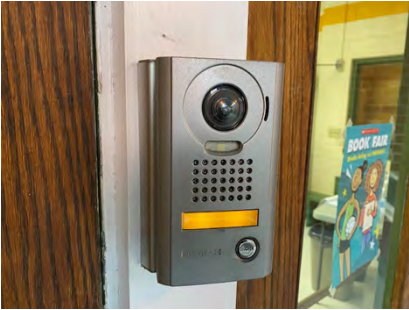
6- School

<p>The intercom at the main entrance is positioned too high off the ground floor level for wheelchair users and there are no access features.</p>	<p>It is recommended that a new intercom be installed which has tactile definition to the buttons and an LED display. The unit should be well contrasted against the background upon which it is seen.</p> <p>All the operational parts should be no higher than 48 inches above the floor.</p>	2	\$
7- School

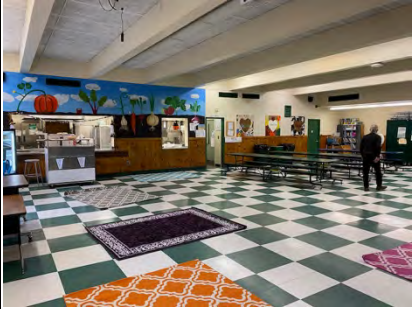
for people with hearing loss and in conformance with Appendix L performance requirements".		
8- School

There is no induction loop within the canteen area to benefit hearing aid users. This area is frequently used by the local community.	It is recommended that an induction loop be installed within the main hall to benefit hearing aid users. A hearing enhancement system, using induction loop, infrared or radio transmission, should be installed in rooms and spaces used for meetings, lectures, classes, performances, spectator sport or films, and at service or reception counters where the background noise level is high or where glazed screens are used.	2	\$
9- School

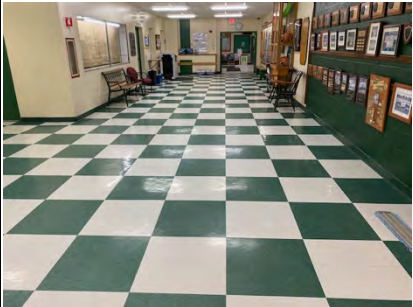
The flooring within the corridors and amongst other areas are extremely 'busy' and may cause potential difficulties for people with impaired vision.	The Braille Institute states – The surface colors and patterns in a room have a huge impact on how well a person may see to locate objects or to move around safely in a space. Avoid floor coverings that have busy patterns that may be confusing.	3	\$

It is recommended that the flooring be changed at the next planned refurbishment for the site.		
10- School

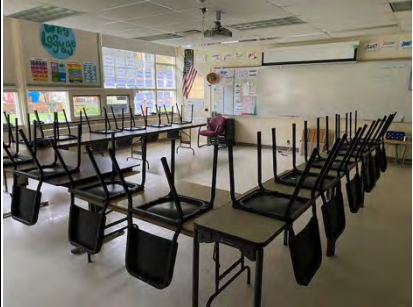
<p>Only one classroom was inspected and it is understood that the local community may use this one (photographed) for various evening classes.</p> <p>The classroom used by the local community does not feature an induction loop. There are also no chairs with armrests provided to accommodate ambulant disabled persons.</p>	<p>Install an induction loop within the classroom to aid those with a hearing impairment.</p> <p>Ensure that there is a chair with armrests available within each of the classrooms that may be used by the local community.</p> <p>Also ensure that any new furniture purchased will suitably color contrast against the background upon which it will be seen.</p> <p>If a seat is too high or too low, or if there are no armrests or side supports, a person may experience considerable discomfort as a result of poor posture. A person may also have difficulty rising from a seated position if the seat is set too low, or if it has no armrests.</p>	2	\$

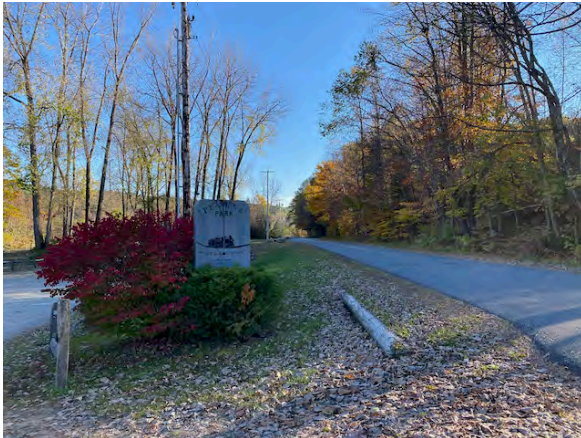
Item	Identification / Photo	Comment	Suggested Recommendation	Priority	Cost Band
1-Peavine Park		Two ADA parking spaces should be considered for the left side car park.	Provide two accessible parking spaces at least 8 feet wide with an access aisle atleast 5 feet wide. This should follow the set guidelines as per ADA [502.2, 502.3]	2	\$

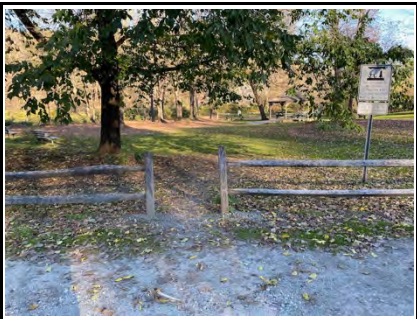
There are no hard standing pathways provided within the park for wheelchair users. This will cause difficulty particularly if the ground is wet.	Consider providing a hard standing pathway within the park to accommodate wheelchair users.	3	\$
3- Peavine Park

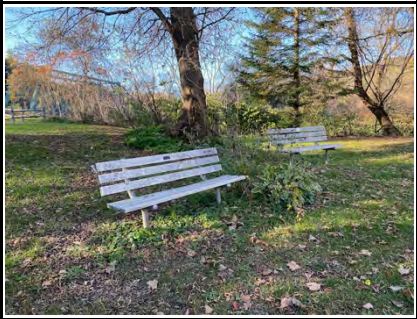
None of the benches have armrests installed to accommodate ambulant disabled persons.	Consider providing benches with armrests. Ensure that the armrests are well contrasted and that there is a space either side of the seat so that a wheelchair user can park alongside a seated companion.	3	\$
4- Peavine Park

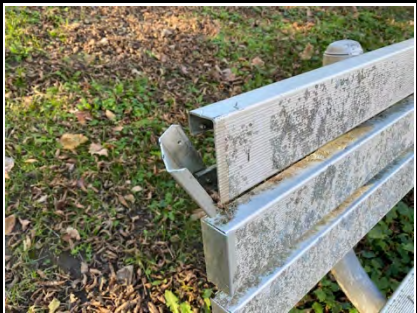
One of the benches closest to the car park has a damaged edge which could cause a potential hazard.	Repair works should be undertaken to the hazard.	2	\$

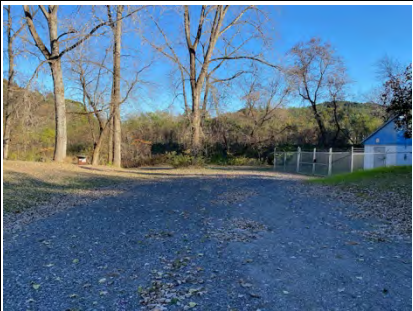
One ADA parking space should be considered for the right-side car park.	<p>Provide one accessible parking space at least 8 feet wide with an access aisle atleast 5 feet wide. This should follow the set guidelines as per ADA [502.2, 502.3]</p>	2	\$

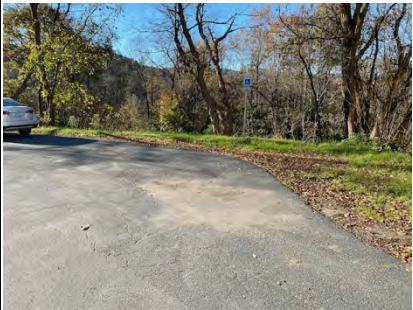
Item	Identification / Photo	Comment	Suggested Recommendation	Priority	Cost Band
1-Town Office

The ADA parking space provided within the Town Office car park is not clearly marked out on the ground.	Mark out the accessible parking space at least 8 feet wide with an access aisle atleast 5 feet wide. This should follow the set guidelines as per ADA [502.2, 502.3]	2	\$

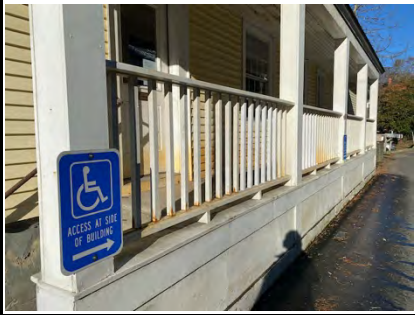
From the car park, the 'Access At the Side of the Building' sign may not be immediately obvious.	It is recommended that a further supplementary sign be installed in clear view of the car park.	2	\$
3- Town Office

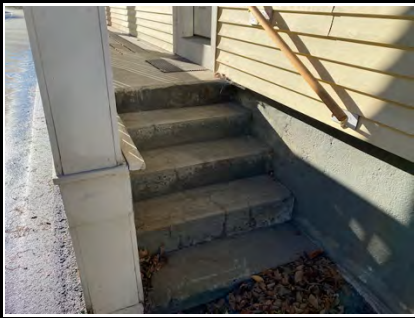
The edge of the step nosings for the Town Hall are not color contrasted. This could cause a potential tripping hazard.	Bright color contrast should be painted to the edge of the step nosings to clearly highlight their presence.	2	\$
4- Town Office

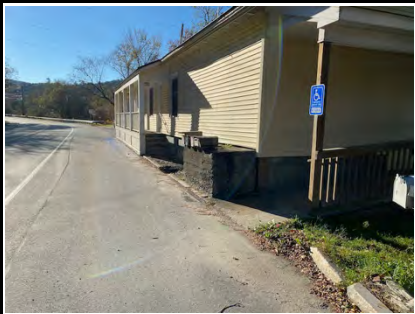
The ADA van accessible parking bay to the front of the Town Hall building is not marked out.	The van accessible parking bay should be marked out at least 11 feet wide with an access aisle at least 5 feet wide. Or At least 8 feet wide with an access aisle at least 8 feet wide [ADA 502.2]	2	\$

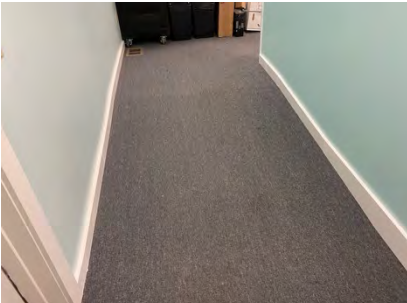
<p>The internal ramp inside of the side entrance is not color contrasted. Numerous people may not see the gradient and this could cause a potential stumbling hazard.</p>	<p>Color contrast should be added to the surface of the ramp.</p>	3	\$

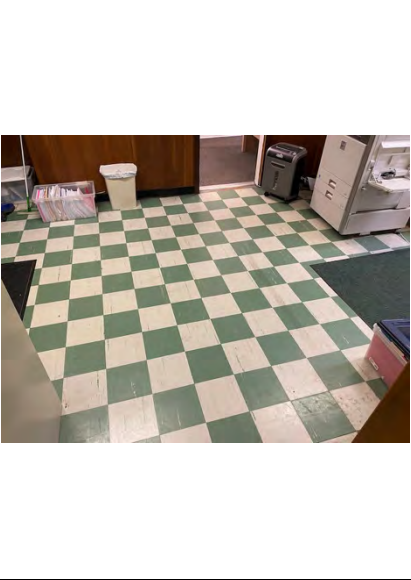
<p>The flooring is extremely 'busy' and may cause potential difficulties for people with impaired vision.</p>	<p>The Braille Institute states –</p> <p>The surface colors and patterns in a room have a huge impact on how well a person may see to locate objects or to move around safely in a space.</p> <p>Avoid floor coverings that have busy patterns that may be confusing.</p> <p>It is recommended that the flooring be changed at the next planned refurbishment for the site.</p>	3	\$
10- Town Office	 	<p>There is no induction loop provided at the counters within the Town Office to accommodate those who have a hearing impairment.</p>	<p>It is recommended that an induction loop be installed to the counters. Signage indicating the availability of the facility should be provided and staff members should be aware in how to use the system.</p>	2	\$

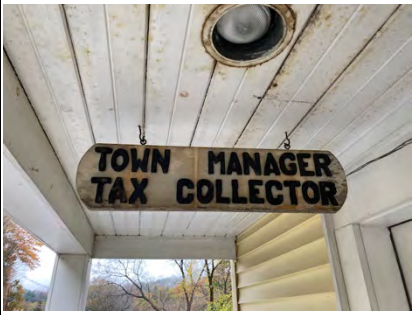
The external signage could be improved. The existing signage is in capital letters and is not pictorial.	Consideration should be given to improving the existing signage. Words entirely in upper case type (capital) should also be avoided. A sans serif type face with a relatively large "capital" height to "x" height should be used.	3	\$
12- Town Office

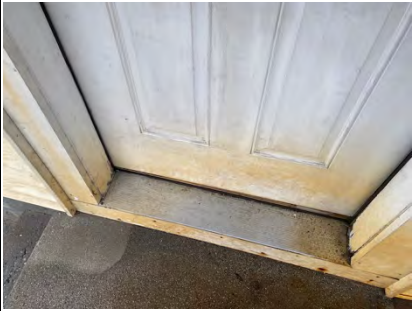
All the entrances except for the side feature a threshold which could cause a potential tripping hazard.	When the doors are replaced, these should be changed with an alternative that feature a level aluminum threshold.	2	\$

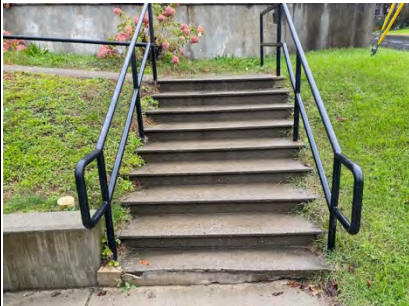
Item	Identification / Photo	Comment	Suggested Recommendation	Priority	Cost Band
1-Post Office

The steps have no color contrast provided to the edge of the step nosings.	Color contrast should be provided to the edge of the step nosings.	2	\$

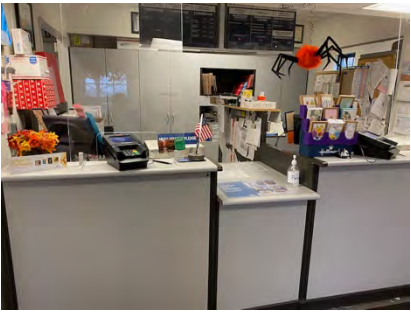
2- Post Office

<p>There is no induction loop provided at post office counter to accommodate those who have a hearing impairment.</p>	<p>It is recommended that an induction loop be installed to the cafe counter. Signage indicating the availability of the facility should be provided and staff members should be aware in how to use the system.</p> <p>Direct Access always recommends an induction loop be installed at service or reception counters. ADA also states, in each assembly area where audible communication is integral to the use of the space, an assistive listening system should be provided.</p>	2	\$
3- Post Office

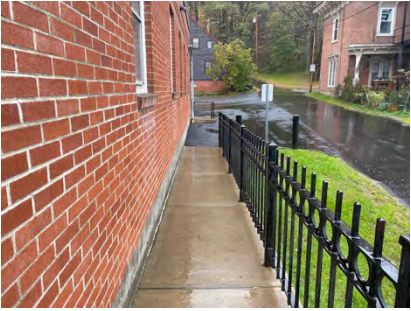
<p>The ramp up to the Post Office entrance at the side does not feature handrails.</p>	<p>A handrail should be installed to both sides which is circular. The handrail should be no less than 1 ¼ inches and no greater than 2 inches in diameter as per ADA 505.7.1.</p>	2	\$

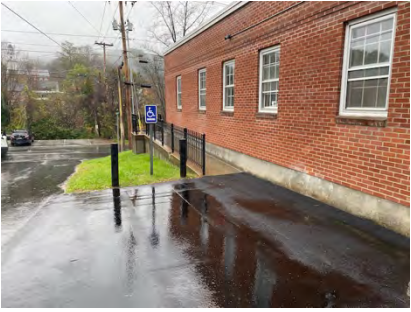
<p>4- Post Office</p>

<p>The ADA accessible parking space is not marked out on the ground.</p>	<p>Mark out the accessible parking space at least 8 feet wide with an access aisle atleast 5 feet wide. This should follow the set guidelines as per ADA [502.2, 502.3]</p>

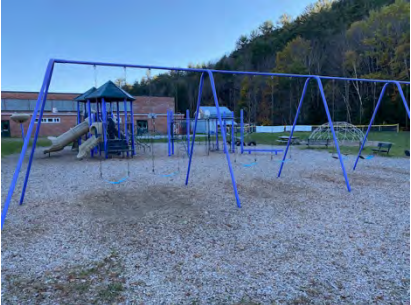
Item	Identification / Photo	Comment	Suggested Recommendation	Priority	Cost Band
1-Bethel Community Playground

There is no play equipment provided for people with disabilities.	<p>There is an opportunity to consider the provision of accessible play equipment within the community playground.</p> <p>Play areas should be designed to be inclusive and accessible for people with a variety of impairments. Bethel could consider installing play equipment which can be used by people with disabilities who require the use of wheelchairs or have mobility impairments.</p>	3	\$

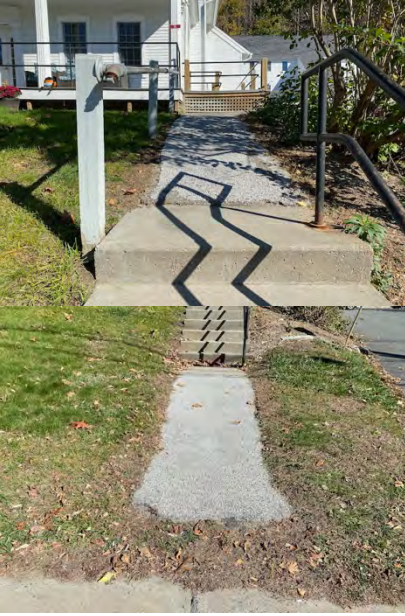
<p>2- Depot 1</p>

<p>The steps have no color contrast and lead to a steep gradient at the start and end.</p>	<p>Ideally this flight and approach should be rebuilt to be more accessible for all. ADA should be referred to for design guidance.</p> <p>In the short term, color contrast should be added to the edge of the step nosings.</p>	<p>1</p>	<p>\$\$</p>
<p>3- Depot 1</p>

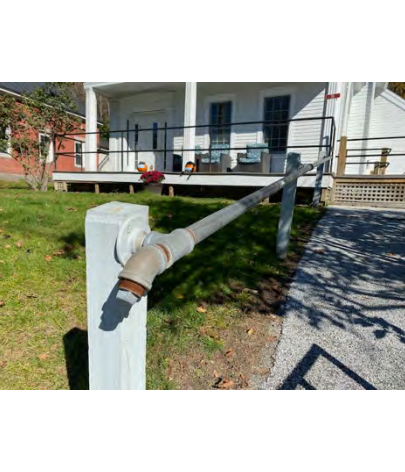
<p>The handrails to one side are of exposed metal which makes them potentially cold to touch.</p>	<p>The handrails should be coated with nylon or a suitable alternative to ensure that they are not cold to touch.</p> <p>In locations subject to extremely cold or hot temperatures, handrails should not become excessively cold or hot to touch, while being of a material that, if necessary, is sufficiently robust to resist vandalism or misuse.</p>	<p>3</p>	<p>\$</p>

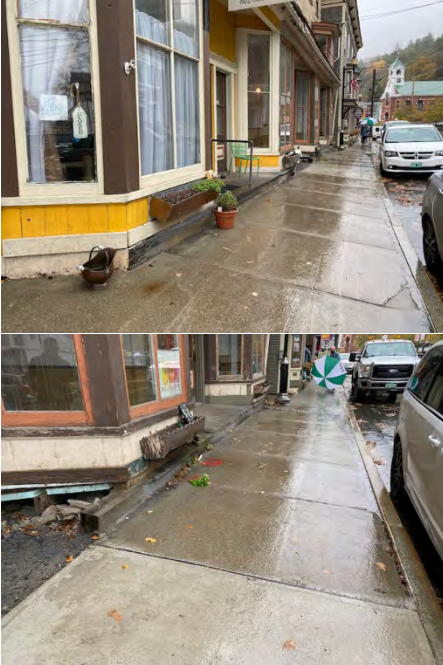
<p>One of the significant challenges of the Main Street in Bethel and impacts on many of the key amenities such as the hairdressers, the sandwich shop, Blossom Block etc is the fact that the building entrances are higher than the sidewalks in front. This results in the majority of the buildings being inaccessible for wheelchair users or for those unable to negotiate steps.</p> <p>This results in alternative means of access having to be sought, different ways of providing services such as potentially installing an assistance bell to the base of the entrances.</p>	<p>The ideal solution and would be a significant benefit to Bethel would be to raise the sidewalk.</p> <p>This would substantially improve accessibility across Main Street.</p>

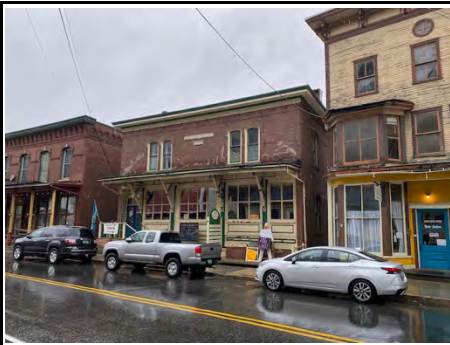
It was identified throughout the days of surveying that vehicles were consistently parking on both sides of Main Street. This makes it very unsafe for pedestrians and cyclists.
