Accessibility Audit and Overview for Bethel Village

Bethel for All: Village Accessibility Plan | Public Version

Prepared by Direct Access Consultancy LLC

October 2021

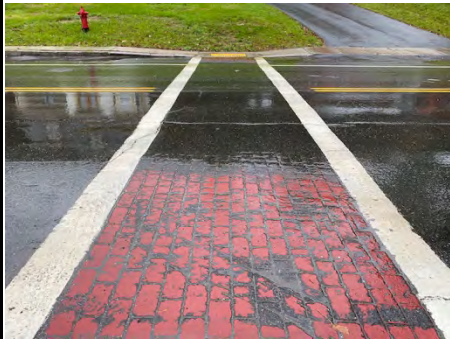
There is an opportunity to really significantly improve the contrast and visibility of the existing crosswalks.

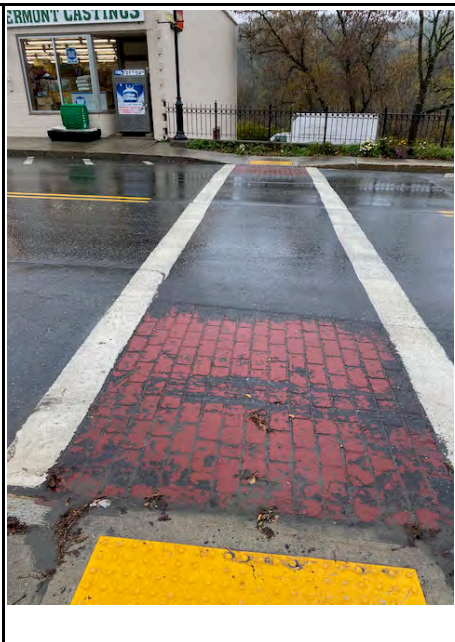
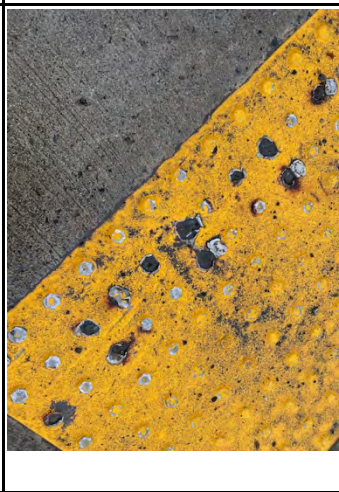
<p>Many of the detectable warning strips are damaged.</p> <p>If the truncated domes are damaged or flat then they will not be detected by people with impaired vision.</p>	<p>Investment is required in this area to replace the current damaged detectable warning strips .</p> <p>Truncated domes in a detectable warning surface need to have a base diameter of 23 mm (0.9 in) minimum to 36 mm (1.4 in) maximum, a top diameter of 50 percent of the base diameter minimum to 65 percent of the base diameter maximum, and a height of 5 mm (0.2 in)</p>

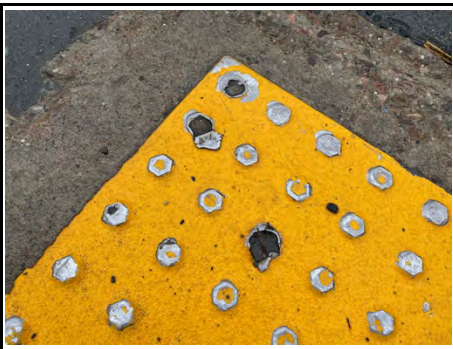
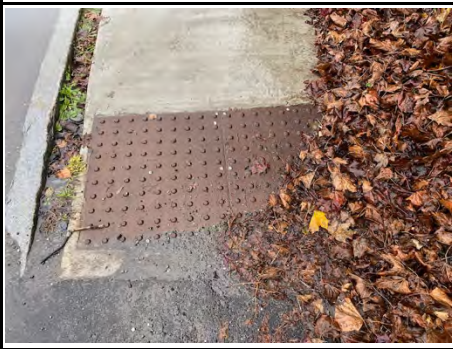
<p>Crossing by Livery Stable Street has a warning strip which is not greatly color contrasted. Whilst this has adequate contrast by VT standards, many people with impaired vision would find it beneficial to have a strip that has greater contrast.</p>	<p>It would be beneficial to have a strip that has greater contrast. It is recommended that this be replaced.</p>

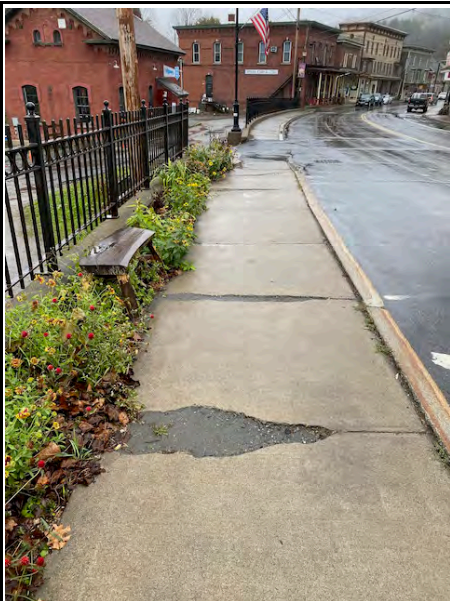
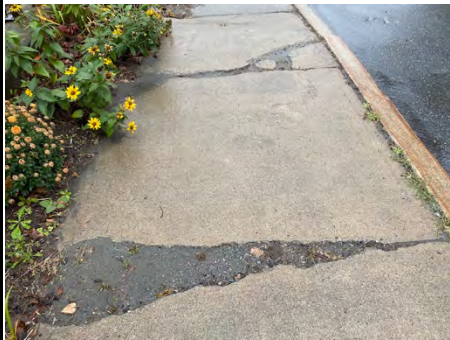
The sidewalk on approach to Babes Bar has damaged sections. These could cause a potential tripping hazard as well as cause difficulty for people with impaired vision or for wheelchair users.

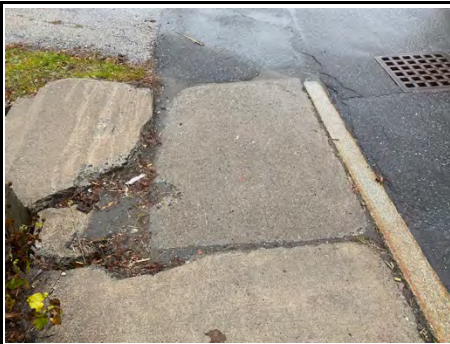
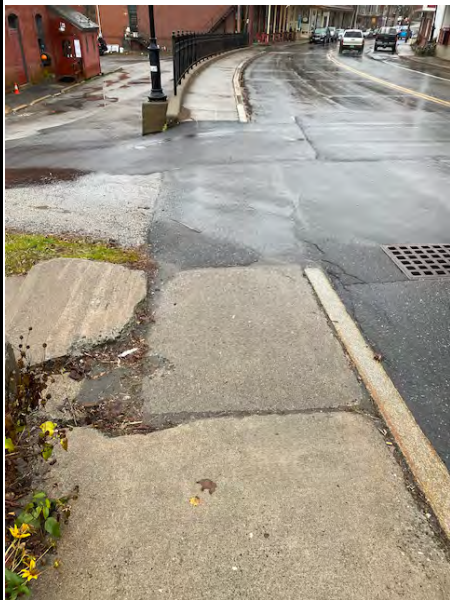
The vehicular entrance for the Babes Bar car park on the left side has no detectable warning strips on either side.

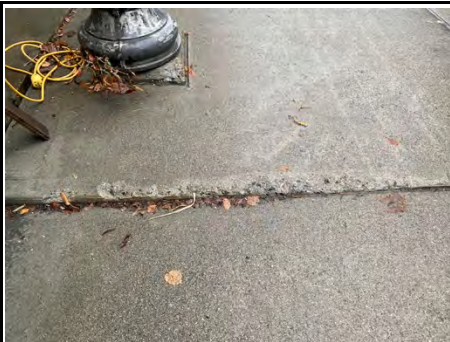
Just before the Sandwich Shop on Main Street there is a potential tripping hazard where the sidewalk is not flush.

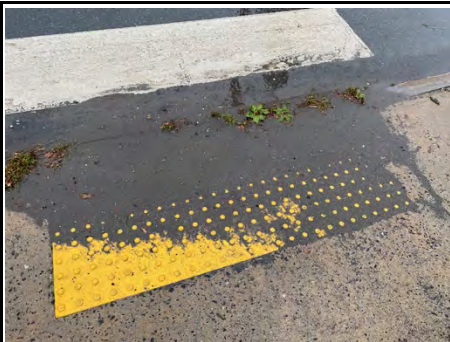
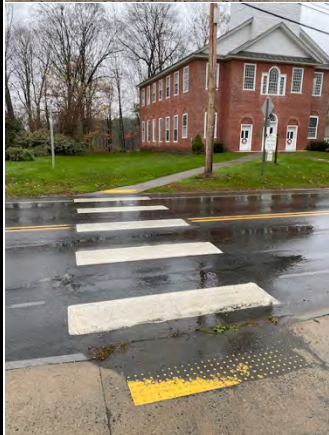
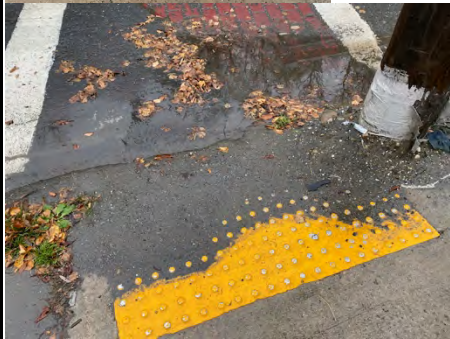
Some of the detectable warning strips are covered in mud and debris. This would result in the truncated domes not being felt by someone with impaired vision. This was identified along Main Street and Church Street.

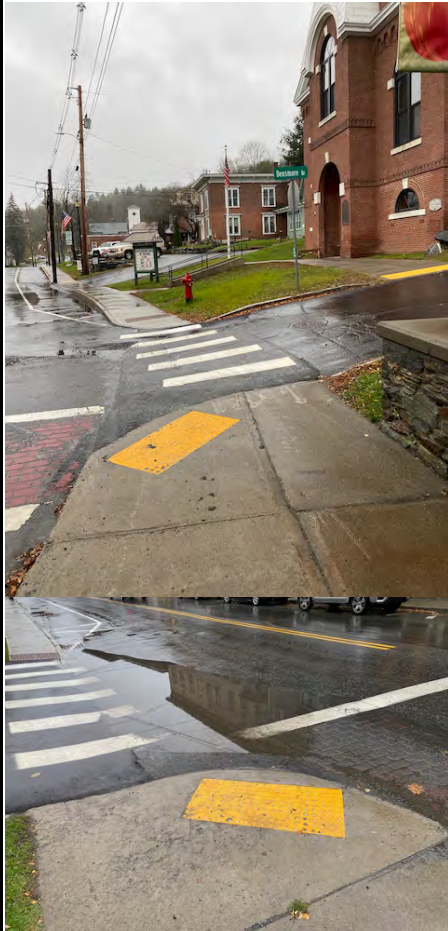
The positioning of the detectable warning strip near the car park entrance adjacent to the Bank is not correctly positioned. It is not advisable to have one detectable warning strip to cover two crosswalks. It is also not aligned which can cause potential difficulty for wheelchair users.

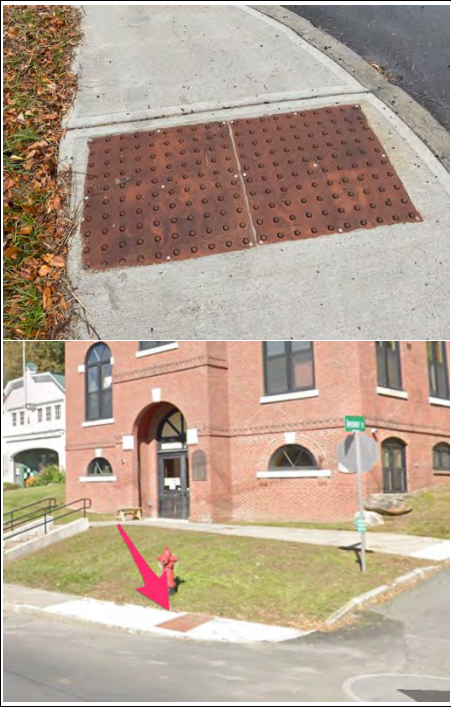
<p>The detectable warning strip opposite the Town Hall is not well contrasted and does not match the strip on the other side.</p> <p>Whilst this has adequate contrast by VT standards, many people with impaired vision would find it beneficial to have a strip that has greater contrast.</p>	<p>It would be beneficial to have a strip that has greater contrast. It is recommended that this be replaced.</p>

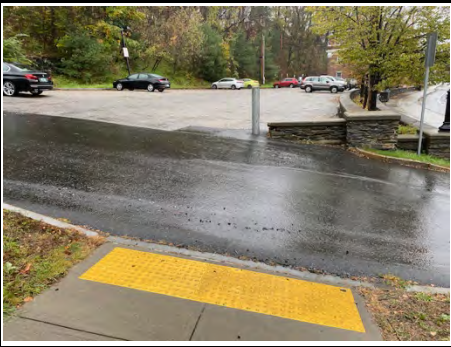
<p>From the Town Hall car park there is a detectable warning strip on one side (Town Hall side) but not on the car park side.</p>	<p>It is recommended that a detectable warning strip be installed on the car park side.</p>

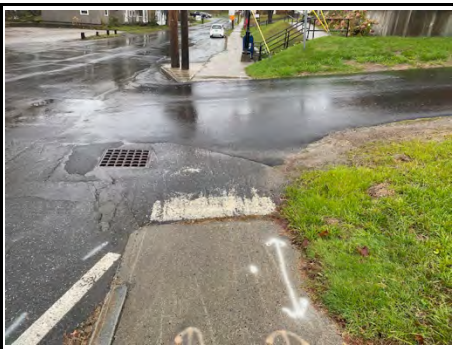
<p>The crossings on approach to the Post Office which is one of Bethels key amenities do not have detectable warning strips installed.</p>	<p>Detectable warning strips are required along this route.</p>

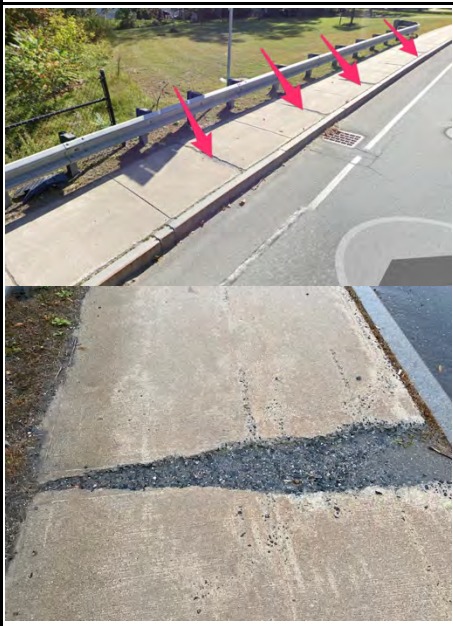
<p>Along the Church Street bridge there are a series of tripping hazards and repair works should be undertaken.</p>	<p>Repair works should be undertaken to eliminate the potential tripping hazards along Church Street.</p>

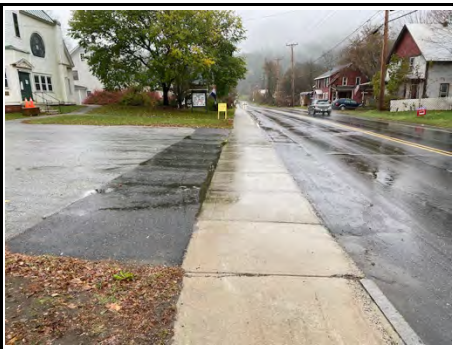
<p>The entrance for the car park between Bandshell Park and the Food Shelf/White Church does not have detectable warning strips either side.</p>	<p>It is recommended that detectable warning strips be installed either side of the vehicular entrance to the car park.</p>

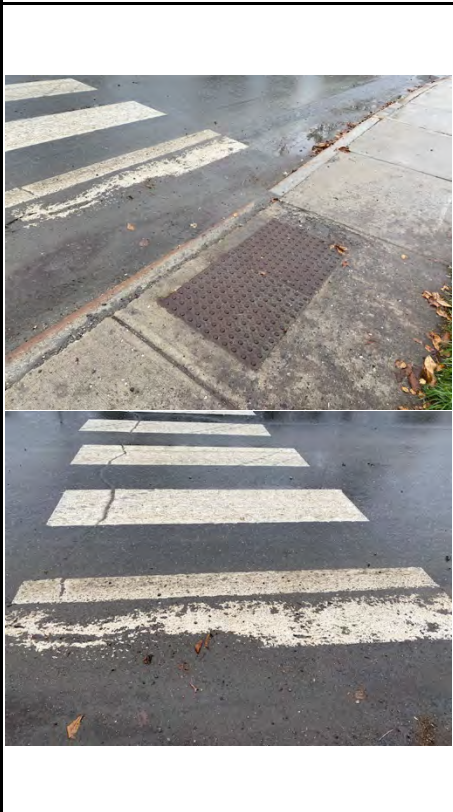
<p>One of the key areas requiring significant investment is the Sand Hill Rd /Pleasant Street intersection. New detectable warning strips are required due to poor contrast.</p> <p>The detectable warning strip at the north part of the island near the sign is not aligned correctly.</p>

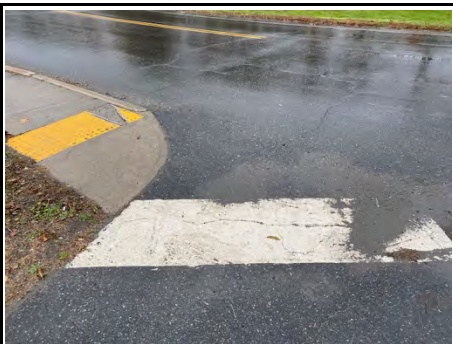
<p>The detectable warning strip at the south part of the island is not aligned correctly.</p>	<p>Identified as one of the key areas requiring works. Additionally, this area is likely to be used heavily by young person’s attending school during peak times.</p> <p>This whole area should be revisited and redesigned. In the immediate short term interim works should be implemented to install new detectable warning strips .</p> <p>From an accessibility point of view, people with impaired vision are highly likely to find this area difficult to navigate.</p>

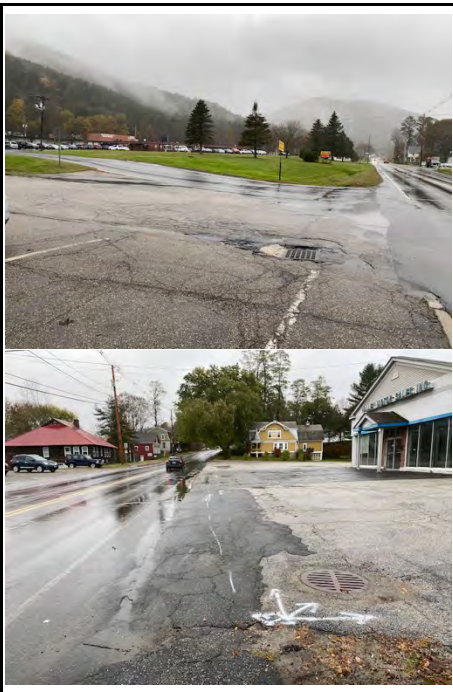
<p>An area of considerable concern is the lack of a suitable sidewalk just before approaching the school. There does not appear to be any suitable segregation between pedestrians and business traffic.</p> <p>There are also no detectable warning strips .</p>	<p>This area should be completely redesigned and requires investment. Many children use this route, and it is shared with the commercial traffic. This was identified as the highest priority within the report.</p> <p>In the short term interim, consideration should be given to urgently marking out walking routes and installing street signage stating to beware of children.</p>

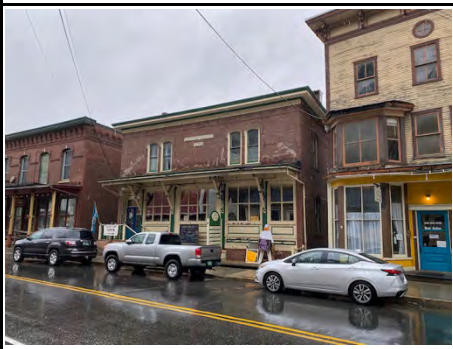
<p>During the days of surveying it was identified that many vehicles were speeding down Main Street. Discussions with the residents of Bethel also highlighted that this was a prevalent issue.</p>	<p>What has been very successful in the UK and other parts of the world is actually artwork produced by children asking motorists to slow down which are then incorporated into street signage. This is something that could be utilized and incorporated by the local school in Bethel.</p>
